## Mercedes C-Class (203)

### Software fault in the control panel affects operation of the recirculating air / fresh air function

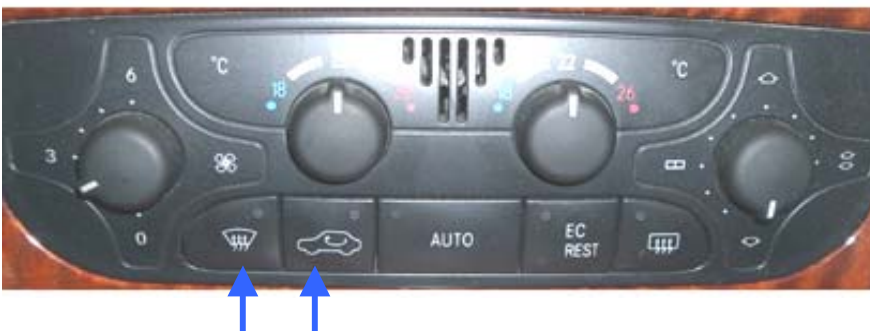
In the case of the above vehicles equipped with climate control air conditioning, it is possible for the recirculating air flap to malfunction. In this event, when the setting for recirculating air is selected, fresh air is drawn in, and vice versa. Correct operation can be restored by using the control panel to carry out a relearning process for the servomotors. To do this, proceed as follows:

1. Switch on the ignition
2. Press the "recirculating air" and "defrost" buttons at the same time (see illustration)
3. Both LED's for the respective buttons should start to flash
4. Wait until only the LED for the "defrost" button remains on (this indicates that the learning process has been completed)
5. Switch off the ignition and remove the key
6. After waiting for at least 40 seconds start the engine

The flap control should now be checked again and should now be working properly.
