Opel Agila model year 2001-2003 with engines Z10XE | Z12XE

Poor engine performance, engine judders

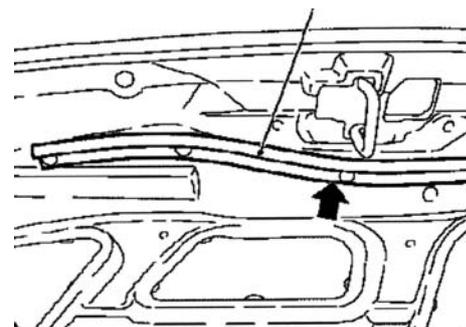
Fig. 1

If there are complaints about the above-mentioned fault, the reason could be a faulty mass air flow meter. In addition, the fault code P0170 (fault in carburetion) is stored. Fog is suctioned in through the suction system and destroys the sensor membrane of the mass air flow meter. In this case the mass air flow meter has to be replaced and an additional seal installed under the bonnet.

- Replace the mass air flow meter.
- Loosen the seal from the bonnet up to the third fastening clip and cut it off (see Fig. 1).
- Attach the new seal to the bonnet using the two fastening clips (see Fig. 2). Make sure that the adhesive surface of the seal is pressed evenly onto the bonnet.
- Delete the fault memory.
