## **Opel Astra-F/G, Vectra B, Calibra, Omega B with engine: C18XE, C18XEL, X20XEV**

### **Engine warning light comes on and fault code P0340 is stored in the control unit.**

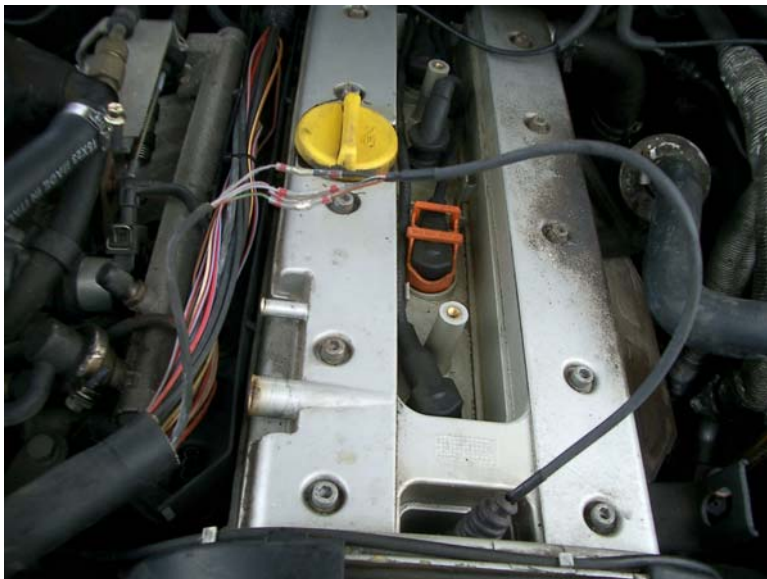
If there are complaints with these vehicles that the engine warning light comes on and the fault code P0340 (camshaft position sensor wire harness) is stored in the control unit, one possible cause can be a poor connection between the camshaft sensor and the connector plug. To eliminate the fault the camshaft sensor and the connector plug have to be renewed.

The Hella part number for the repair set (sensor and connector plug) is: 6PU 009 121-311.
