Opel Corsa B manufact. year 93-95
Opel Tigra manufact. year 95
All versions with A/C

Noises from the footwell

Bulletin

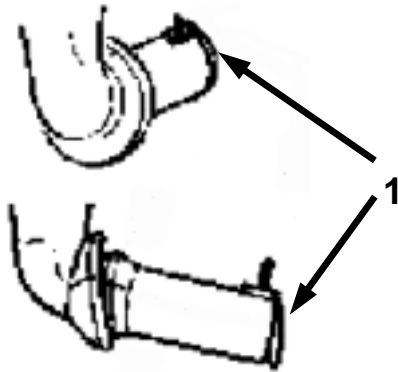
If the above mentioned fault is queried, the cause could be the flap (1) of the condensed water drain. These rattling noises occur, if the A/C blower is in position 2 or 3. In this case the flap must be removed from the condensed water tube. This operation can be carried out in the engine compartment.
