Opel Omega B All models with climate control

Difference between the set temperature and the interior temperature.

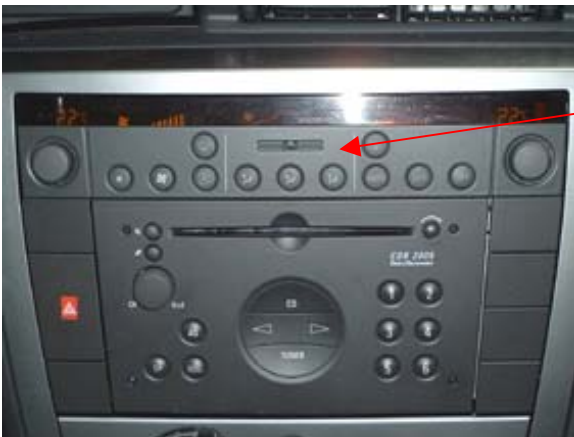
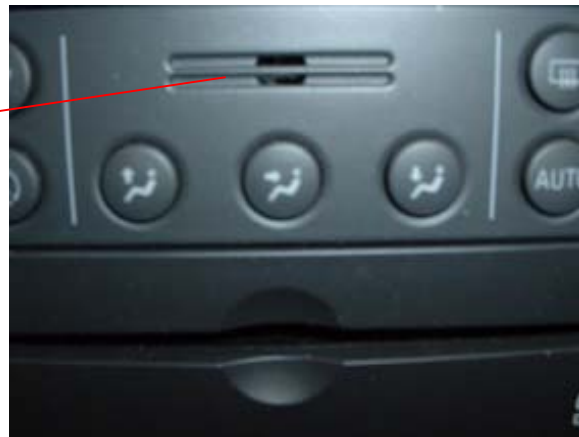
On this vehicle it is possible that the set temperature on the display is different to the interior temperature. This is caused by the interior temperature sensor. The sensor is touching the bracket housing. Due to this, the measurement is incorrect. To rectify the problem the sensor must be moved away by bending carefully. To do this, insert a thin object through the slots of the climate control panel, into the middle of the housing and move the sensor away from the housing.
