## **Opel Vectra B From model year 1996**

### **ABS lamp illuminates, fault code 37 in the control unit.**

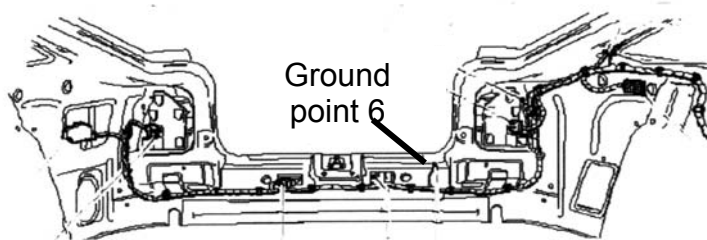
Interior view - end face of luggage compartment

If there are complaints with these vehicles that the ABS warning lamp illuminates and fault 37 is stored in the ABS control unit, a poor ground connection may be the cause. Fault code 37 means "Interruption – supply line to stop light switch" The ground connection at point 6 in the vehicle luggage compartment is affected (see illustration).

To eliminate the fault, the ground connection must be cleaned.

After this, the fault memory must be deleted and the system must be checked to make sure that it is working perfectly.
