## **Opel Vectra-C Model year from 2003 to 2005 All vehicles with adaptive running light**

### **Control lamp for lighting illuminates.**

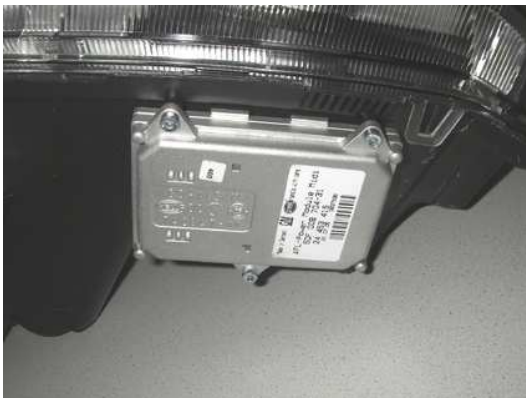
If there are complaints about the above-mentioned fault, the cause could be a faulty power module. In addition, fault codes B1461 and B1462 may be stored. This fault occurs mainly when driving on poor roads. Therefore, the customer should be asked about this. When troubleshooting, the fault can be simulated relatively easily. First, delete the fault memory and then drive the vehicle along a poor road. Depending on the quality of the road, the fault will be displayed after a short period. If this is the case, the affected power module on the headlight must be replaced. As the module is fitted on the underside of the headlight (see illustration), the headlight must be removed in order to carry out the repair.

A new module was used from vehicle identification no.:  
W0L0ZCF6851100331.
