Opel Zafira 2.0 DI 16V From model year 10/1999

Bulb replacement Dipped beam, right

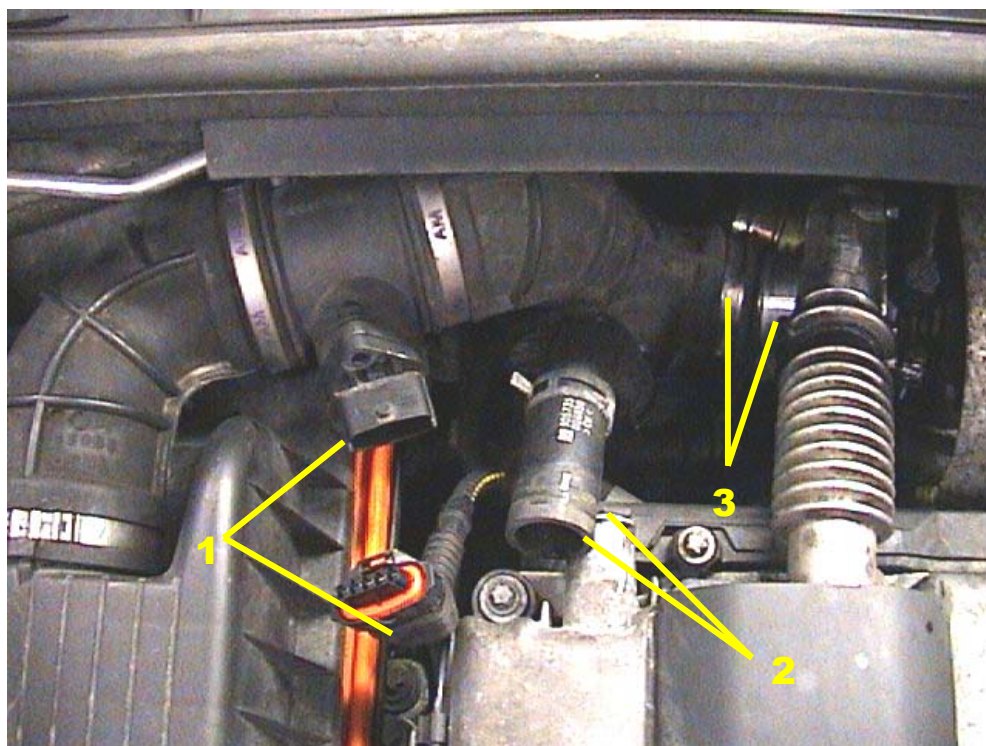
Photo 1

- Disconnect the plug from the mass air flow meter (Photo 1 / item 1) (loosen the catch from below).
- Remove the vent pipe from the valve cover (Photo 1 / item 2)
- Remove the pipe connection on the turbocharger (Photo 1 / item 3)
- Loosen the 4 attachment clips from the top part of the air filter housing
- Remove top part of the air filter housing
- Remove bottom part of the air filter housing by removing the screw
- Remove the indicator bulb with its holder (Photo 2 / item 1)
- Loosen the H7 bulb of the dipped beam light with socket by turning it 45° anti-clockwise and lifting it out (Photo 2 / item 2)
