Bulletin

Renault, Citroen, Peugeot All models with drum brakes

Poor braking with the driving brake and parking brake.

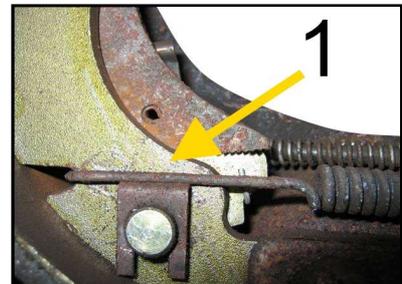
If one of the errors listed above occurs on these vehicle models, the cause may stem from a vertically mounted safety clip on the brake shoe. (Fig. 1)

The lower brake shoe spring presses on the safety clip, thereby preventing the adjusting element from moving. In addition, this can result in slippage during adjusting, leading to damage to the gear teeth. In this case, the position of the safety clip has to be corrected.
