Renault Twingo (C06/S06)

Replacing the air distributor control knob

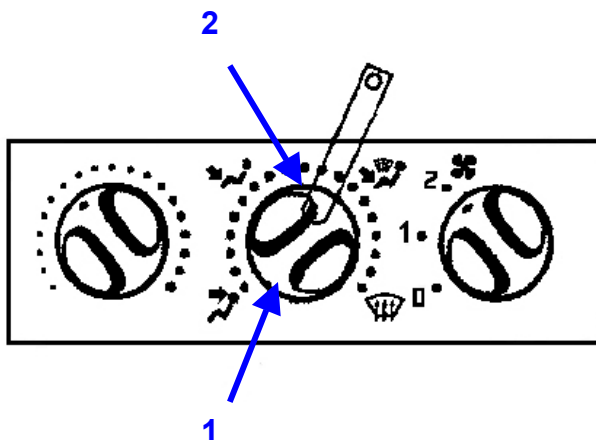
With the above-mentioned vehicles the control knob for air distribution (drawing, pos. 1) on the heating/air conditioning operating unit can break. This affects operating units with a blue control knob. This can be replaced without having to remove the whole operating unit. To do this, prise the faulty control knob off with the aid of a valve adjustment measuring gauge (0.4 mm) as follows:

- Push the measuring gauge between the operating unit and the control knob (drawing, pos. 2)
- Pull the measuring gauge forwards and pull the control knob forwards at the same time.
- Move the measuring gauge through 180° and repeat the procedure until the control knob can be pulled off
- If appropriate, pull residue off the control axle or push it to the back
- Insert new control knob
