Saab 9-5 **With air-conditioning**

Noises from the condensed water drain.

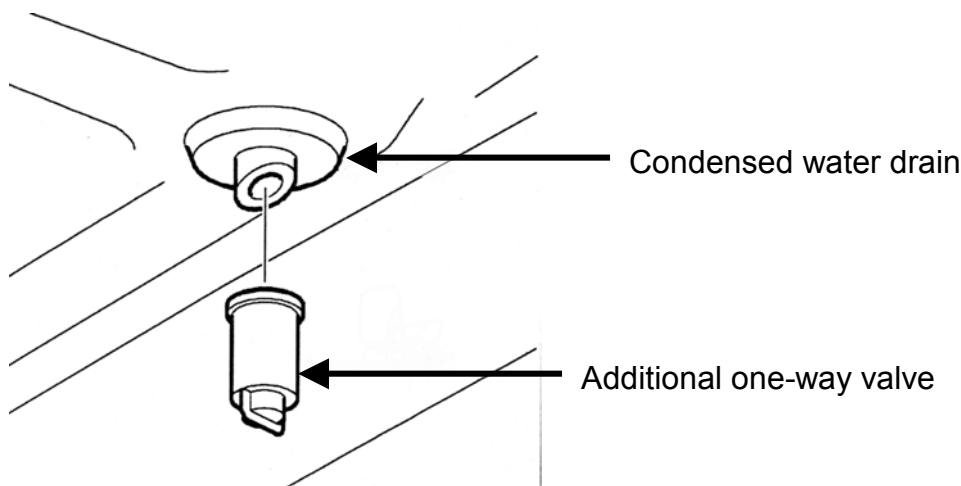
If a gurgling noise can be heard in the inside of the vehicle, a possible cause could be the air-conditioning water drains. The drains are located under the vehicle, on the right and left side body sill near the front seats.

Onto the condensed water drains additional one-way valves must be bonded.

To fit the one way valves, clean the water drains and spread glue on them. Then press the one-way valves onto the drains.

The additional one way valves are available from Saab.
