BULLETIN

Seat Ibiza (6J) Model year: from 2009 onwards Engine: 1.6 TDI

Exhaust gas recirculation radiator Engine warning light comes on

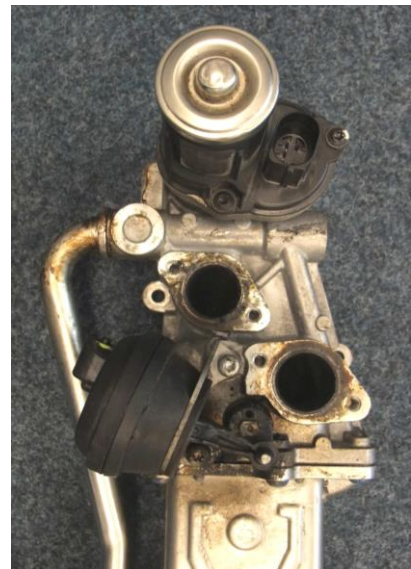
Figure 1

The exhaust gas recirculation radiator unit (EGR radiator) is fitted with a vacuum cell and an electric actuator motor (Figure 1). The EGR radiator should be examined according to the following criteria:

- Internal coking
- Functionality of vacuum cell
- Functionality and control of electric actuator motor
- External and internal leaks

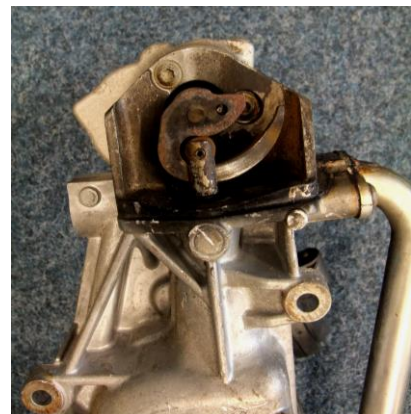
Figure 2

Furthermore, the mechanics of the actuator motor (Figure 2) and the vacuum cell must be checked to ensure that they run smoothly. They may often jam or fail to run smoothly, leading to faults.
