# BULLETIN

## Seat

## Mii

### Radiator fan permanently in operation

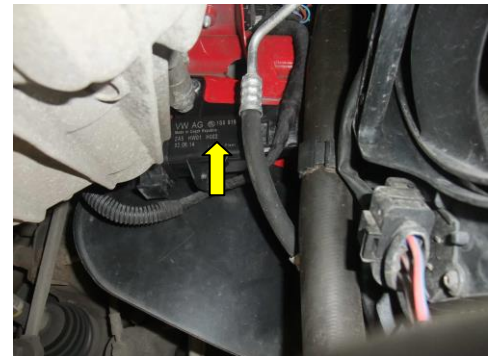
To remedy this, the engine control unit is updated and, if necessary, the radiator fan control unit replaced. The ECU is located between the transmission and the wheel arch liner (see figure).
