Volvo S40/V40 **Model year: with diesel engine from** **1999, with petrol engine and air-** **conditioning from 2000**

Noticeable vibration when radiator fan runs at stage 1 or 2.

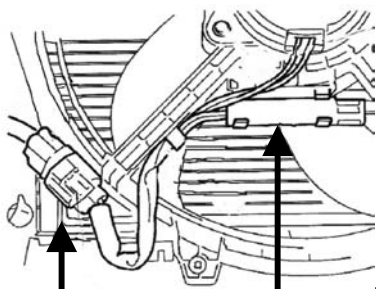
Plug/series resistor

- Disconnect the battery (caution: note down the radio code).
- Disconnect the connection plug from the radiator fan, clip out the series resistor.
- Remove the lower engine cover.
- Insert the additional holder and install the cables and the series resistor through the centre hole of the holder.
- Fasten the additional holder with the screws supplied. The upper holding screw of the radiator fan is replaced by a new one.
- Connect the connection plug, clips the series resistor in and reinstall the engine cover.
- Reconnect the battery and enter the radio code.

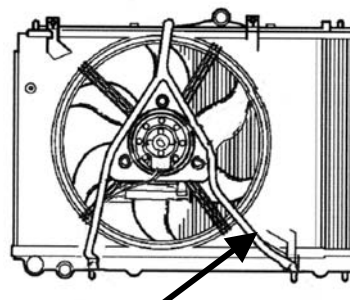
New holder

Installation is identical for diesel and petrol engines, only the holders have different shapes.
