Volvo V70 Estate up to model year 2000

Bulb replacement in the upper part of the combination rear lamp.

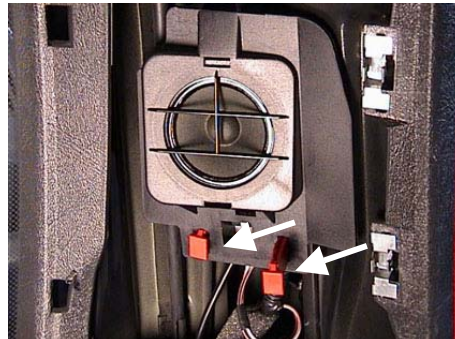
Fig. 1

- Unclip the loudspeaker cover (Fig. 1).
- Pull out the two red stoppers (Fig. 2) of the loudspeaker attachment.
- Unhook the lower loudspeaker bracket hook and pull out the loudspeaker bracket downwards (Fig. 3).
- Unclip the bulb holder (Fig. 4).
- Replace bulb, check function
- Refit components in reverse order.
