VW

Golf 3 (1H1/1H5)

Engine: all

Loss of coolant

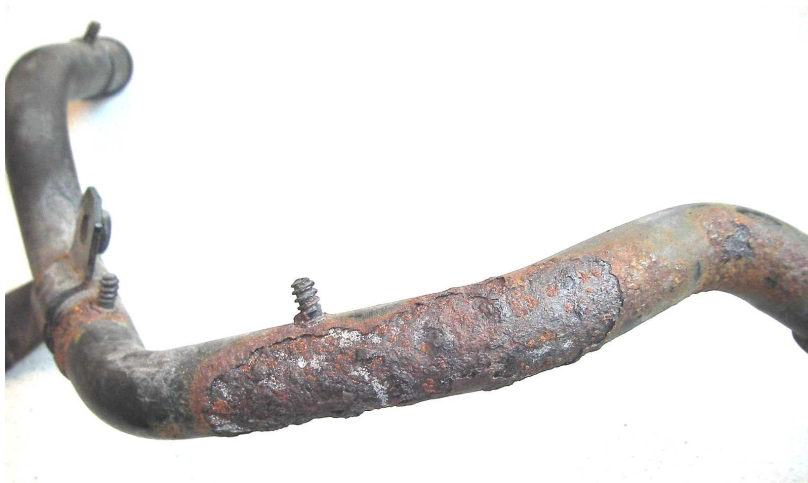
With the above-mentioned vehicles, there can be a loss of coolant at various points in the engine compartment. During troubleshooting, particular attention should be paid to the plastic coolant flanges on the cylinder head and the coolant pipe. Pink-coloured efflorescence/traces of coolant are signs of a leak. Leaky plastic flanges should always be replaced, since the attempt to seal them is not usually successful. The coolant pipe often still looks OK from above, but has heavy signs of corrosion or even spots of rust perforation when seen from below (photo).
