## ***Volkswagen Golf IV With manual temperature control***

### **Air recirculation function**

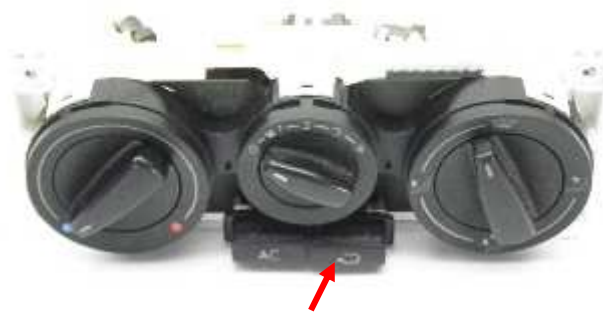
The above vehicles can experience a supposed failure of the air recirculation function.

The indicator light in the air recirculation switch (figure) can fail prematurely in the above vehicles. This mistakenly leads to the assumption that there is an electrical fault in the switch. Before replacing the switch or carrying out extensive troubleshooting, the light bulb should be checked or replaced to make sure it works.
