VW Golf4/Bora up to 10.99

Sanden-compressor: Noise/without function

Bulletin

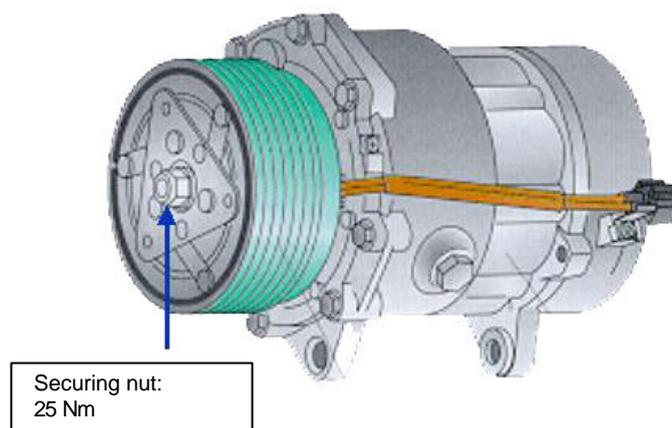
It can occur with this vehicle, that the securing nut becomes loose, this is due to a wrong torque being applied to the compressor-shaft nut. This can lead to noises or even to the failure of the compressor.

After inspection of compressor-shaft, magnetic-coil and fastening nut, for continued use the nut should be tightened to 25 Nm.
