VW

Passat (3B, 35i)

With Motometer instrument cluster

Various functional failures

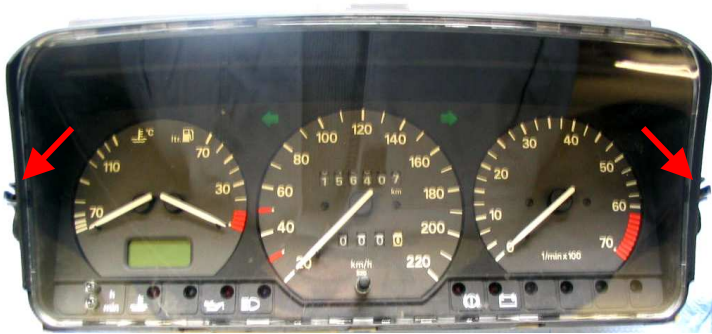
Fig. 1

- Remove the 2 screws from the plastic cover (Fig. 1), remove the cover
- Remove the temperature/fuel gauge and the revolution counter
- Remove the 4 screws for the speedometer, remove the speedometer (Fig. 2)
- Remove the screw on and the screw next to the voltage stabilizer (Fig. 3)
- Carefully remove the circuit board, pressing lightly from behind and keeping an eye on the internally-located snap-fit tabs while doing so
- Check the connection pins for receiving the central plug (Fig. 4)
- Using a magnifying glass (Fig. 5+6) to check the

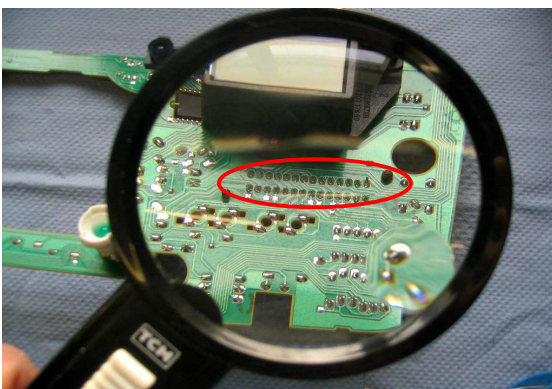
Fig. 5

soldering points of the central connection plug and, if necessary, resolder
