## **Volkswagen Passat Type: 3BG (B5) Model years until 2005**

### **Interior air / odour**

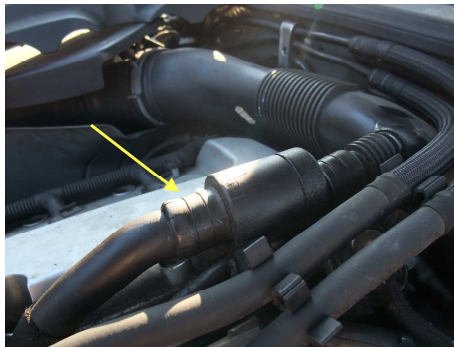
Figure 1 / view  
- porous hose -

Unpleasant odour inside the vehicle. No typical musty odour caused by microorganisms on the evaporator surface. It may be caused by porous hoses of the engine ventilation.  
(See Figure 1.)

In this case, replace the affected engine breather hoses, as the smell enters the passenger compartment through the vents.

In addition, check the surrounding hoses (including the area of the mounting brackets) and replace or clean them if necessary.

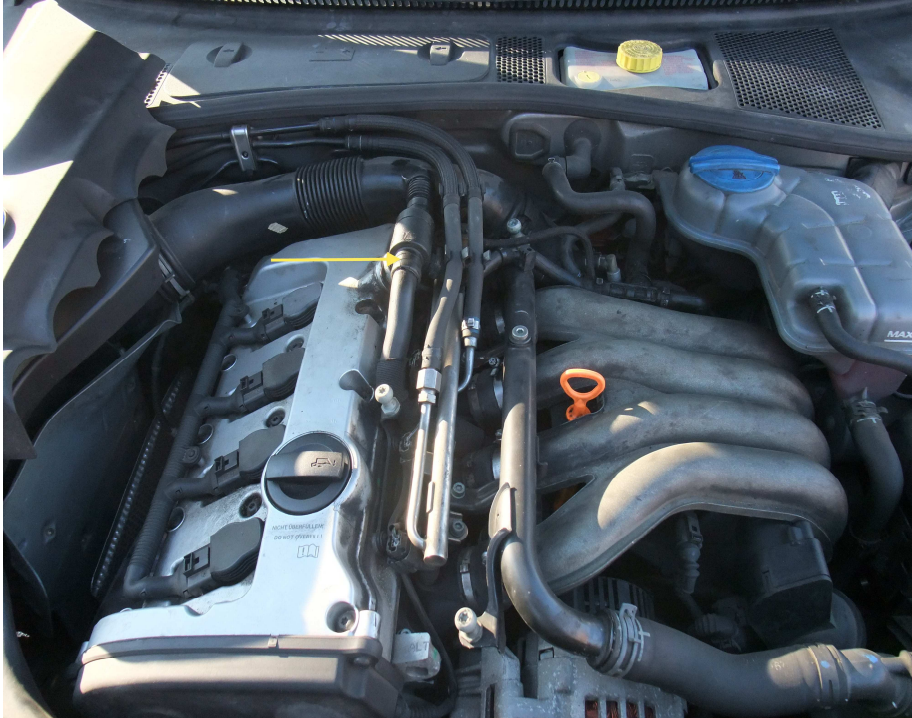
Figure 2: View / location in the engine compartment without cover

Figure 2+3 showing the location of the engine breather hoses.
