VW Polo (6R/6C) Model year: from 2009 onwards Engine: 1.6 TDI

Exhaust gas recirculation radiator Engine warning light comes on

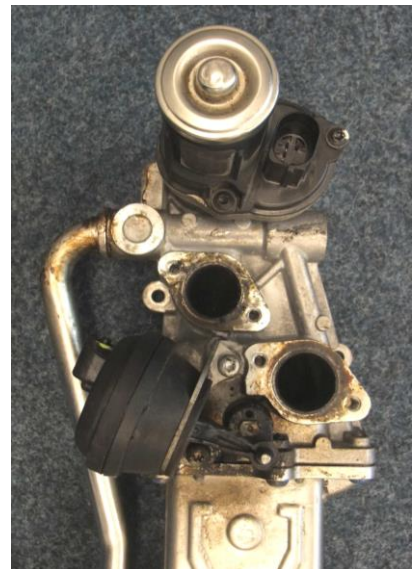
Figure 1

The exhaust gas recirculation radiator unit (EGR radiator) is fitted with a vacuum cell and an electric actuator motor (Figure 1). The EGR radiator should be examined according to the following criteria:

- Internal coking
- Functionality of vacuum cell
- Functionality and control of electric actuator motor
- External and internal leaks

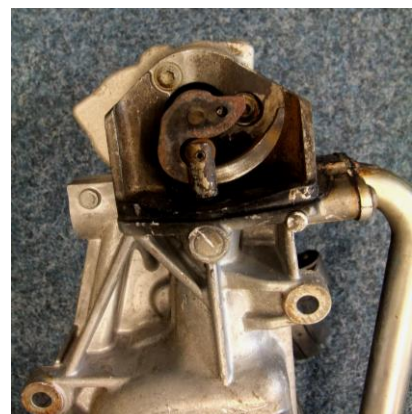
Figure 2

In addition to this, the mechanics of the actuator motor (Figure 2) and the vacuum cell must be checked to ensure that they run smoothly. They may often jam or fail to run smoothly, leading to faults.
