VW Polo Type: 6N2

Chassis No.: 6NYY500001 - 6NYY600000

Noises from the centre vent

Bulletin

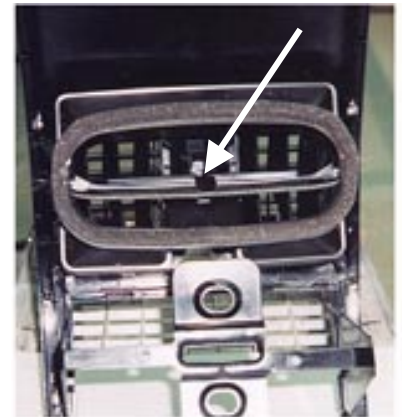
It is possible on this vehicle, an opened centre vent flap makes rattling noises at higher blower speeds.

This is due to a too big a gap between the fixing and the thumb wheel.

To remedy this, lubricate the adjusting rod using a lubricant suitable for use with sythetic material.
