BULLETIN

VW

Up

Radiator fan permanently in operation

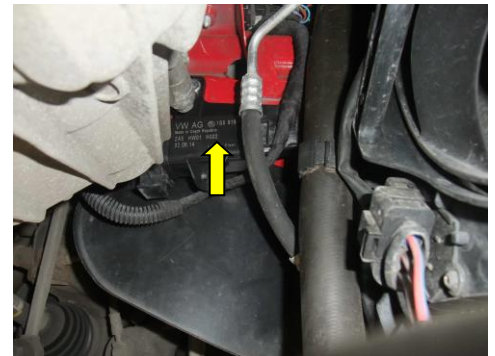
The ECU is located between the transmission and the wheel arch liner (see figure).

To remedy this, the engine control unit is updated and, if necessary, the radiator fan control unit replaced.
