Checking the tensioning and deflecting pulleys during the inspection

Audi, Seat, Skoda, Volkswagen

1.4; 1.4 16V

INA 0003

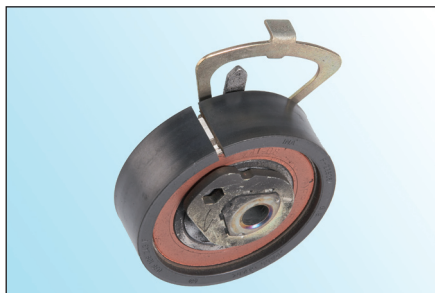
Fig. 1

With reference to several models produced by the manufacturers named above with 8 V and 16 V engines, in a few instances the toothed belt tensioning pulley (**fig. 1**) and/or the toothed belt deflecting pulley (**fig. 2**) may show evidence of damage in the area of the pulley running surface.

Damage to the pulley running surface may, under some circumstances, lead to damage to the toothed belt and, subsequently, to breaking of the toothed belt.

We recommend that all belt drive components are visually inspected at 30,000 km or, at the very latest, at 60,000 km.

Should you discover damage to the pulley running surfaces, replace the damaged components.
