# LuK Clutch Academy

## 2003 Mini One

This month, REPERT Alistair Mason replaced the clutch on a 2003 Mini One, which had covered 103,000 miles. The customer reported that the clutch pedal was heavy when used.

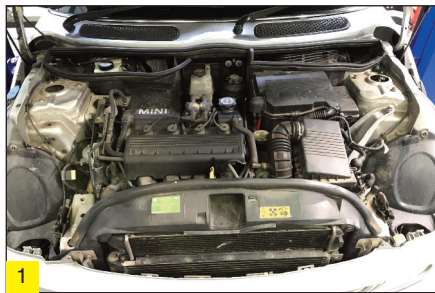
Ensure a locking wheel bolt tool is nearby before starting the repair. With the vehicle placed on the ramp, open the bonnet (Fig 1), remove the battery cover, then disconnect the battery.

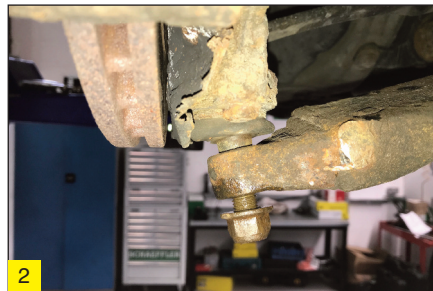
Raise the vehicle lift to gain access to the underside, detach the engine undertray, disconnect both bottom ball joints (Fig 2) and the anti-roll bar links, before removing the lower engine torque arm and the subframe retaining bolts.

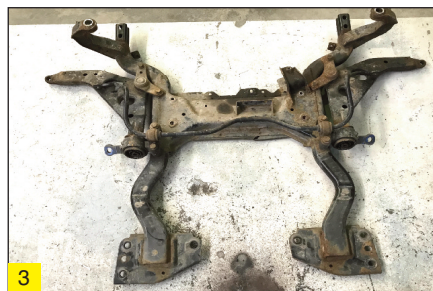
Allow the subframe to lower slightly, to gain access, and undo the four steering rack retaining bolts. Unscrew the power steering motor mounting bolts, too. Support the subframe and ease it out of the front cross member tubes. Once free, lower and stow it out of the way (Fig 3).

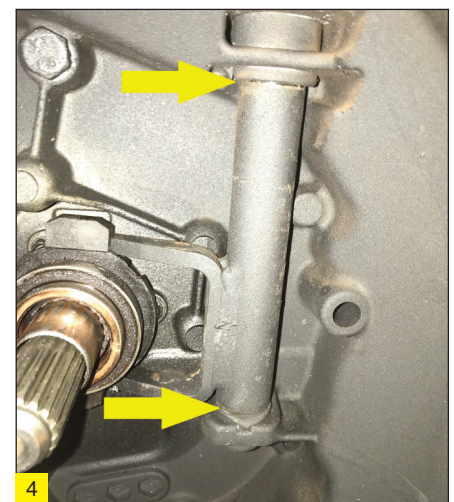
Detach the clutch and inspect it. In this instance, the clutch was in a serviceable condition; the release system was then inspected for correct operation, and this is where the problem was identified: the bushes for the release fork had worn badly, causing the release fork to operate at a slight angle and requiring extra force, to operate the clutch (Fig 4).

With the new clutch fitted, the focus switches to the release mechanism. With new release fork bushes obtained, remove the release bearing and then knock out the retaining pin that secures the clutch arm lever to the clutch release fork. Remove the clutch arm lever and the clutch release fork; in practice, everything had seized solid.

Disconnect the clutch release fork from the bell housing and inspect for any wear; in this instance, the release arm was serviceable, so just the bushes were replaced.

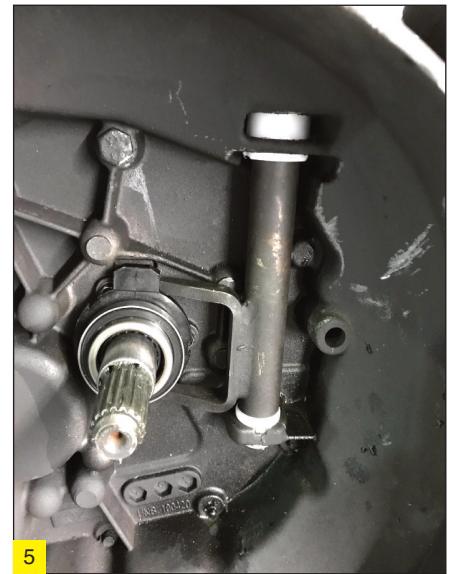
Fit the new release bearing (Fig 5). Apply a light smear of high-melting point grease to the gearbox input shaft splines and wipe off any excess.
