LuK Clutch Academy

Fiat 500 Abarth

REXPERT's Alistair Mason replaced the clutch in a Fiat 500 Abarth. With the manufacturer recommending that the engine be removed first, Alistair decided that course was traumatic, and more pressingly, it was impossible! So he followed a more conventional approach, even though the booking time was longer than the original five-and-a-half hours allotted. Below is a commentary of how he achieved this.

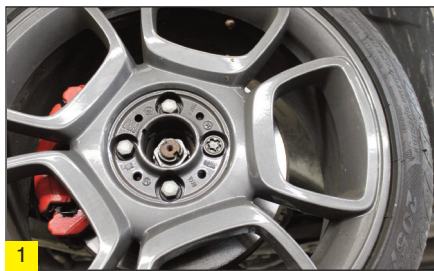
With the car on the ramp, Alistair used extra blocks of wood to access the jacking points, so he didn't damage the Abarth's body kit on the ramp legs. He noticed that the standard socket needed to be modified to remove the driveshaft nuts, as there was a generous radius in the cavity preventing a standard socket getting on the nut (Fig 1).

As a result, Alistair decided to leave the wheels on and swing the complete chassis leg, with driveshafts attached, to release the CV joints from the gearbox.

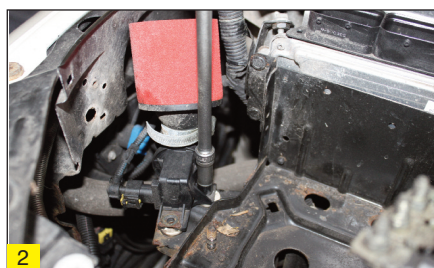
Disconnect the diverter valve with its flashy red filter (Fig 2) then remove the two ECU plugs. Expectedly, a number of cable and hose retaining clips later (and not forgetting the three fixings), the battery tray could be lifted free.

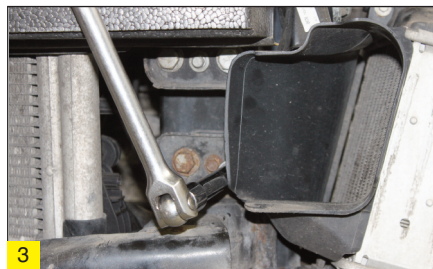
With the bumper cover removed, Alistair could see the LH subframe leg retaining bolts, shared with the bumper armature (Fig 3), so these were removed as well. At the rear of that leg were two additional fixings which had to be removed.

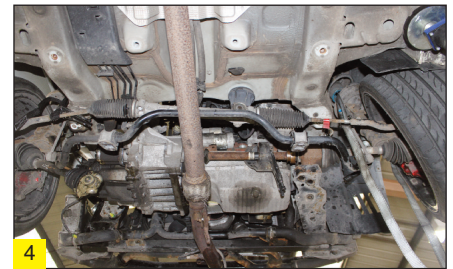
With the job opening up (Fig 4), Alistair had to go back up top to release yet more clips, starting with the water temp sensor plug and all the other multi plugs, until the harness could be stowed safely out of the way of the bell housing bolts. The intercooler pipe was retained by a bracket and nut that needed detaching; then the clutch concentric slave cylinder could be disconnected and the pipe stowed safely after removing it from another clip or two.
