# LuK Clutch Academy

## Peugeot 206 1.1P

This month, Alistair Mason, inspects a 2005 1.1 petrol Peugeot 206, which had covered more than 75,000 miles. It was difficult to get the vehicle into gear, as the clutch was not fully disengaging and there was a ‘scrapping’ noise emanating from the bell housing area.

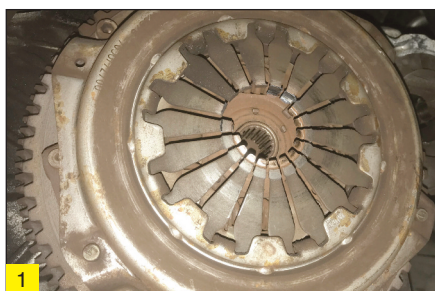
1

With the gearbox removed, the fault was easily identified: some of the clutch diaphragm fingers had been ground away and snapped off (Fig 1). The release bearing was also inspected and was deemed unserviceable, as it had damage to the contact area and no lubrication in the bearing (Fig 2).

There could be a couple of reasons for this fault:

- The bearing coming into constant contact with the clutch, causing the bearing to get hot and seize. This is caused by the driver resting their foot on the clutch pedal.
- The release system’s alignment was not correct, i.e. release fork lever bushes worn, release fork twisted/bent.
- The release bearing guide tube was worn, not allowing the release bearing to return correctly.

Remove the old clutch, remove the glaze from the flywheel by using Emory cloth and clean it with brake and clutch dust cleaner. Mount the new clutch plate onto the gearbox input shaft to ensure correct fitment.

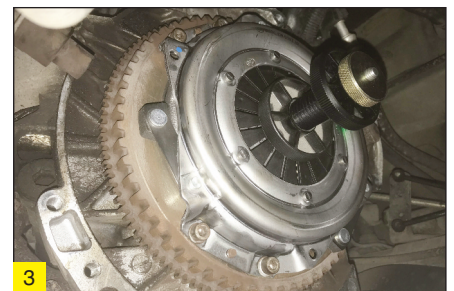
3

Using a clutch alignment tool, mount the new clutch assembly onto the flywheel (Fig 3).

Ensure the clutch plate is facing the correct way, indicated by ‘Gearbox Side’ or ‘Getriebe Seite’, then tighten the bolts evenly and sequentially and, finally, torque to the manufacturer’s specification.
