LuK Clutch Academy

Peugeot 5008 1.6HDi

This month, REPERT's Alistair Mason replaced the clutch in a Peugeot 5008 Semi-Automatic 1.6 HDi. The semi-automatic gearbox in the 2012 model is actually a manual gearbox with an automatic shift and clutch actuation. While it is a significant job, technicians should be able to complete the job in four hours with REPERT's advice.

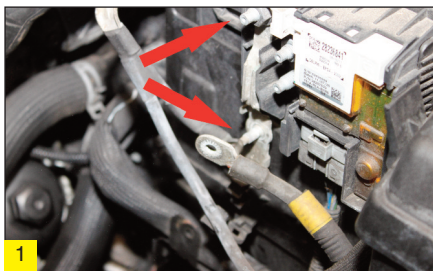
Disconnect the battery positive lead, unbolt the harness/fusebox (Fig 1) and remove it so the fusebox can be placed on top of the engine. Unbolt the negative terminal and disconnect the multiplug to remove it, then take off the battery clamp and the battery charge status unit (Fig 2).

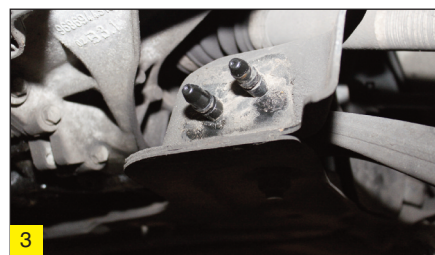
To remove the gearbox, the subframe has to be removed, so unbolt the lower ball joints and the anti-roll bar links. Remove the front subframe bolts, the undertray support bracket and the subframe side legs that, when unbolted, slide off two spikes (Fig 3) on the subframe.

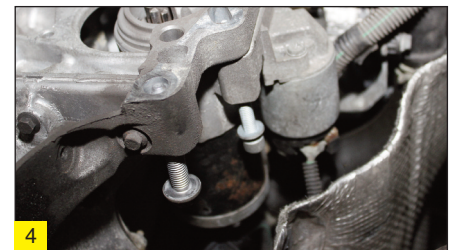
After detaching them, leave the starter in position (Fig 4). Remove the catalyst support bracket, which, again, conceals a bell housing bolt, which can then be removed. Don't forget to unbolt the earth strap from the rear of the gearbox.
