LuK Clutch Academy

Suzuki Alto 1.0 K10B

The owner of a 2010 Suzuki Alto, fitted with a 1.0-litre, three-cylinder K10B engine that had covered more than 70,000 miles, had reported clutch slip. The slip was confirmed by a short road test and clutch replacement was advised.

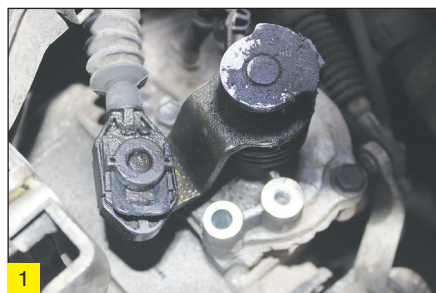
Disconnect the reverse light switch multiplug and stow the loom in the inner wing. Disconnect the gear change cables from the selector mechanism by removing the 'U clip' from the front cable (fig 1) and then detach it from the ball pivot, disconnect the

rear cable by removing the bolts from the pivot point bracket and removing the assembly (note – there is a small nylon bush located in this assembly that can fall out), slide the outer cables upwards out of their support bracket and stow in the bulkhead

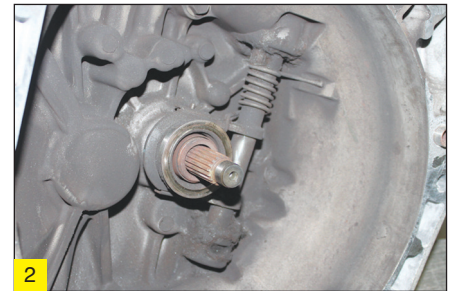
At this point, we noticed that the release fork/arm had restricted movement due to the build-up of clutch dust at the pivot points and would not return to its rest position (fig 2) so we cleaned out the clutch dust with clutch and brake dust cleaner, and inspected the release system for any wear and

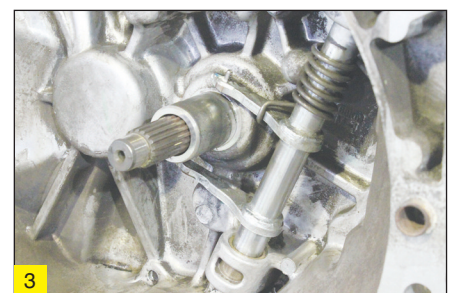
checked for correct and full operation (fig 3).

Fit the new release bearing, applying a very small amount of high melting point grease to the pivot areas, as these are all metal. Apply a small amount of high melting point grease to the gearbox input shaft splines, then mount the clutch plate, confirming it is correct, and remove the clutch plate and wipe off any excess grease. Now mount the new clutch assembly onto the flywheel using a clutch alignment tool, ensuring the clutch plate is installed correctly with 'Gearbox side' or 'Getriebe Seite' markings on the clutch plate facing the gearbox, tightening and torquing the bolts evenly and sequentially.
