LuK Clutch Academy

Vivaro 2.0CDTi

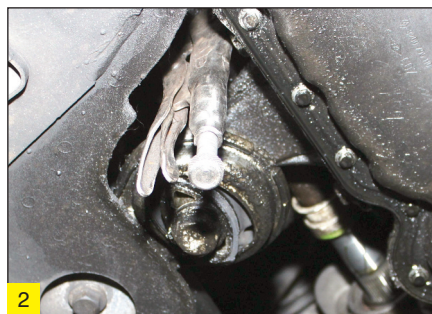
gearbox, as it locates through a support bearing. The bracket will need to be removed by releasing two bolts (fig4). Swing the suspension leg to the side, and the driveshaft and bearing will slide out of its location. Secure the driveshaft in place, using a pair of locking grips through the support bracket to stop it from returning to its original position (fig 2).
