LuK Clutch Academy

Peugeot Bipper 1.2 D.

This month, REPERT's Alistair Mason replaced the clutch on a Peugeot Bipper 1.2D. The Bipper is a popular small van with many companies, including motor factors.

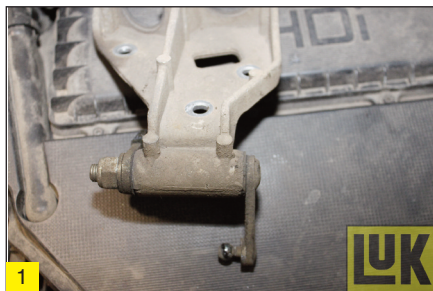
Pop the gear mechanism cables off the ball pivots, detach them from their bracket and stow safely out of the way. Unbolt and remove the gear mechanism bracket and mass damper, then check that the selector arm (Fig 1) is free to rotate on this bracket, as this can be a source of gear change complaint.

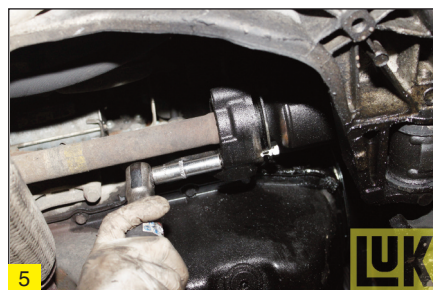
receptacle. While it is draining, mark the RH driveshaft centre bearing retaining plate (Fig 5) as the holes are offset, then remove the bolts and refit the cleaned gearbox drain plug.

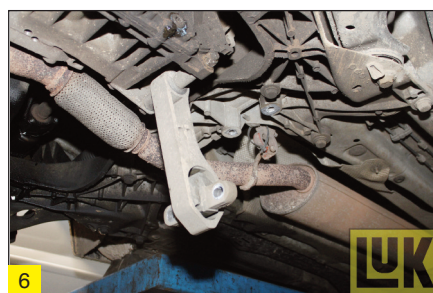
Pull the knuckle away from the car and remove the LH driveshaft all together, then support the knuckle with a cable tie or similar to prevent damage to brake hoses etc. Unbolt the rear engine tie rod at the rear, and allow it to hang on the gearbox (Fig 6). Unbolt the lower bell housing bolts.

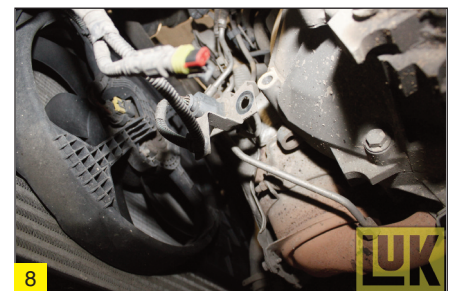
Support the engine and remove the gearbox mounting fixings. Detach the upper bell housing bolts and the one securing the harness bracket (Fig 8) at the front of the engine; however, leave one to secure it. From within the wheel arch, remove the gearbox mounting bracket bolted to the gearbox.
