## Issue No. 7/2013:

### MAHLE oil filter insert OX339/2D: oil pressure problems after replacing filter

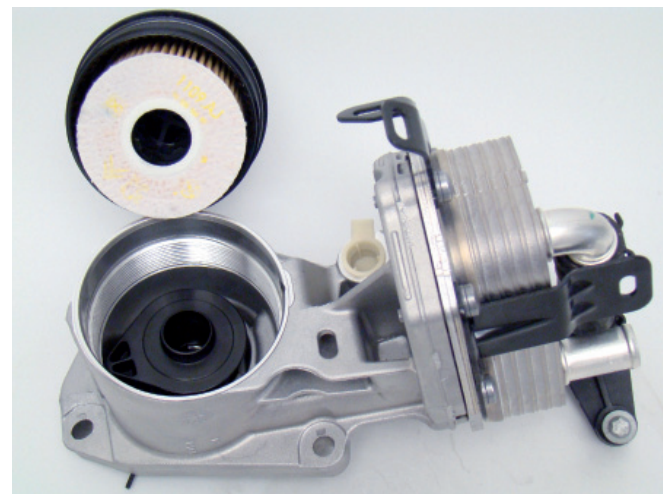
The majority of oil filter housings used in original equipment and in the aftermarket have an integrated, spring-loaded oil return valve. Unscrewing the filter insert releases the valve allowing the oil in the housing to flow into the oil sump. This ensures that the complete volume of oil can be drained during the oil change.

The purpose of the valve is to open the oil return channel when the filter is removed, and to close this channel when the filter is fitted. However, experience shows that the sealing ring in the valve can become brittle—with the result that the valve jams and is unable to properly seal the oil pressure channel or the oil return channel, thereby preventing the build-up of adequate oil pressure.

*Oil filter housing with integrated oil return valve*

In order to prevent serious engine damage caused by insufficient oil pressure, MAHLE recommends to check the valve's freedom of movement before each oil filter change—the simplest way is to do so by hand, by directly actuating the valve or by briefly pressing the oil filter insert to be fitted into the housing.

If the valve jams, or does not move freely to the upper stop, the oil filter housing should be replaced. The housing should also be replaced when the oil pressure indicator lights up after an oil change and there is no other plausible reason for it to be activated. Unfortunately, it is not possible to simply replace the valve because it is a press fit in the housing.
