Issue no. 01/2017: Piston damage due to broken piston cooling nozzles

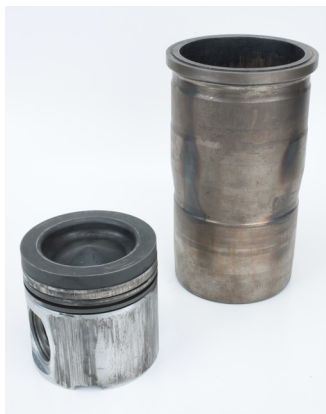
- The piston has scoring and seizing marks on the skirt.
- The piston crown, ring belt, and top land are melted or scorched.
- The cylinder liners are discoloured in places, or even cracked.

Figure 1: Overheated Ferrotherm piston (steel piston crown and aluminium skirt) showing seizing marks, with cylinder liner

IMPORTANT! Always remove the cooling nozzles when carrying out any repairs requiring removal and fitting of the piston and connecting rod. Make sure the cooling nozzles are properly aligned and in good working order when fitted; gasket residue and deposits may clog the nozzles and should therefore be thoroughly removed.

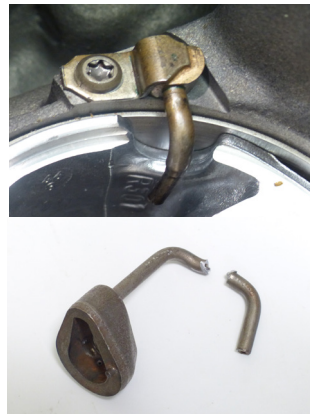
Quite often, this damage occurs when the piston and connecting rod are removed and fitted, and the piston cooling nozzle remaining in the engine block is inadvertently bent or broken.

Figure 2: Cooling nozzle fitted (top) and broken off (bottom)

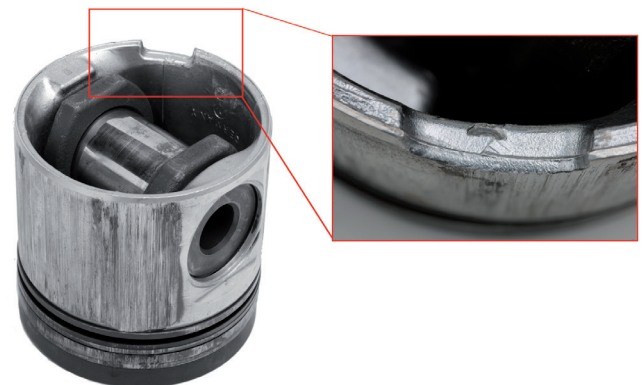
Figure 3: Noticeable marks on piston skirt indicate cooling nozzle impact
