THEME: CONDENSER CORROSION

CONDENSER CORROSION - POSSIBLE ISSUES

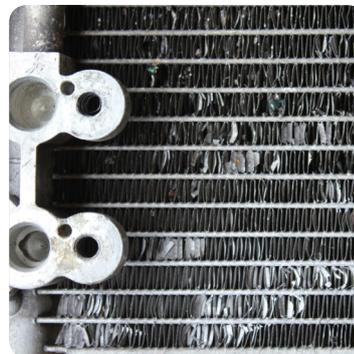
Deterioration of condenser fins – Even if the condenser does not leak and seems to be tight, the heat exchange capacity can have been reduced significantly. As corrosion attach to the thin aluminum fins, the working surface area is reduced, which will reduce the overall heat exchange capacity of the condenser.

Visibly deteriorated condenser fins

Especially, pay attention to the condenser bottom part, where tubes and fins are mostly exposed to extensive humidity and aggressive salt spraying. Oil residues on the condenser indicate leaks. Always replace a condenser that is leaking or has missing/deteriorated fins.

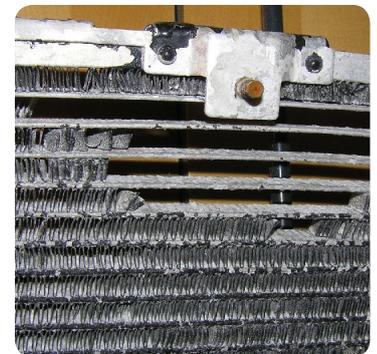
Lack of fins – As the fins corrode over time, they will fall out of the condenser. With the number of fins reduced, the condensation process will become significantly more ineffective, creating an increased overload on the compressor. **Removal of only one fin row from the condenser can reduce its thermal performance by up to 3%!**

Several rows of missing fins caused by condenser corrosion

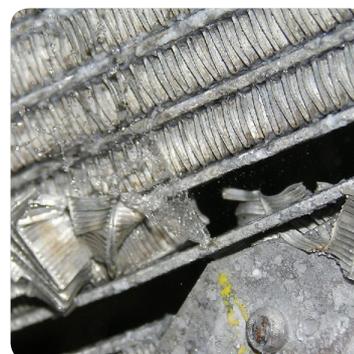
Leaking condenser – Testing has shown that a condenser with missing fins, due to corrosion caused by saltwater, will eventually start to leak. The leakage is caused as the lack of fins destabilizes the condenser construction, making it more vulnerable to wear and tear. As the refrigerant disappears, the system will not function properly. Furthermore, as the lubricant cannot be distributed in an empty running system, the compressor will be exposed to overheat and seizure.

Leakage caused by missing fins

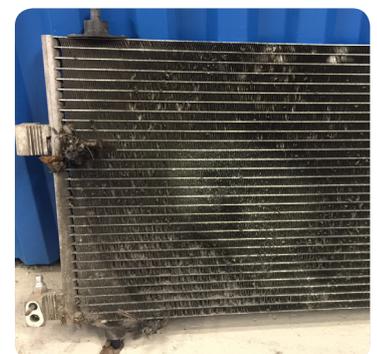
Seems tight, however, a condenser in such a condition cannot perform well and must definitely be replaced

When replacing condensers, choose parts with corrosion protection applied. This prolongs its lifespan considerably. Advanced saltwater tests have shown that condensers that are treated with corrosion protection can function up to eight times longer than a non-protected condenser. Nissens applies special protection to +500 condenser models particularly exposed to corrosion.
