Condenser corrosion possible issues

Nissens®
DELIVERING THE DIFFERENCE

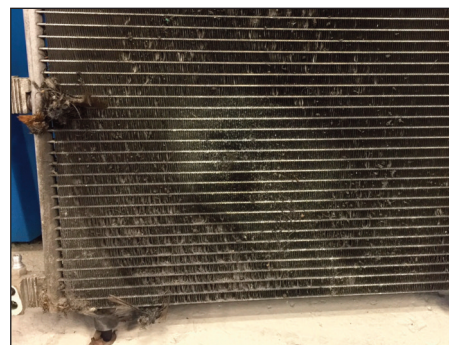
It may not leak, but this condenser cannot perform well and must definitely be replaced

Especially, pay attention to the bottom of the condenser, where tubes and fins are mostly exposed to extensive humidity and aggressive salt spraying. Oil residues on the condenser indicates a leak. Always replace a condenser that is leaking or has missing/deteriorated fins.
