DAMAGED DIAGNOSIS

PISTON RINGS

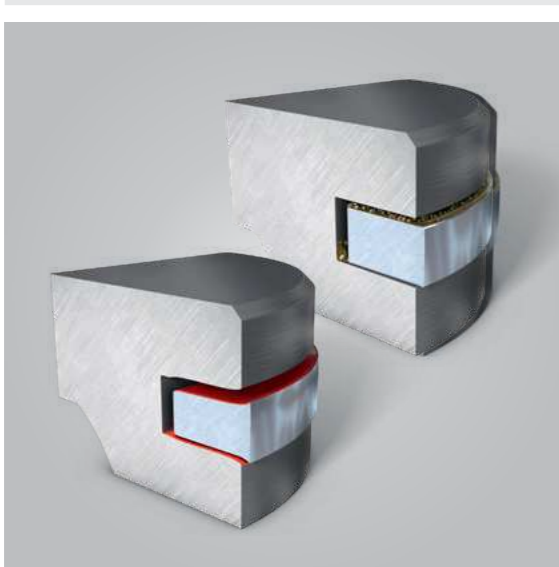
Dirt in the intake air

Dirt that reaches the combustion chamber settles in the ring grooves where it causes abrasive wear in the ring grooves and at the piston ring flanks. This results in excessive ring height clearance and consequently to a deterioration of the guidance of the piston rings in the ring grooves. The rings will become bent during use and start to flutter. If the rings are severely worn at the sides, they can break.

Consequence: High oil consumption and poor performance

Remedy: Regular air filter maintenance, particularly in dusty areas

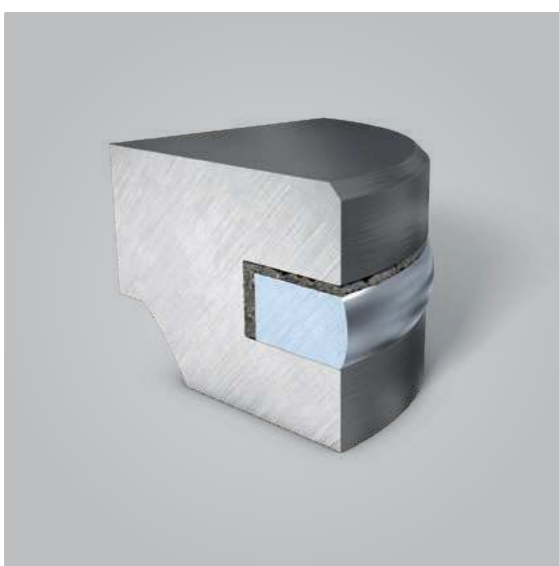
Blocked piston rings

Piston rings must be able to rotate freely in their ring grooves during operation (exception: two-stroke engines). If the piston rings are blocked by carbon deposits or dirt in the ring grooves, they are no longer able to seal properly and will not wear uniformly. If the rings get stuck in the grooves, the sealing effect is no longer guaranteed. This causes a blow-by of combustion gases on compression rings, and results in the passage of oil into the combustion chamber on oil rings.

Consequence: Piston seizure, high wear and high oil consumption

Remedy: Regular air filter maintenance and use of engine oil with the right oil specification for the engine
