Malfunction in the engine lubricating system

Loss of oil pressure caused by fracture on oil filter cap

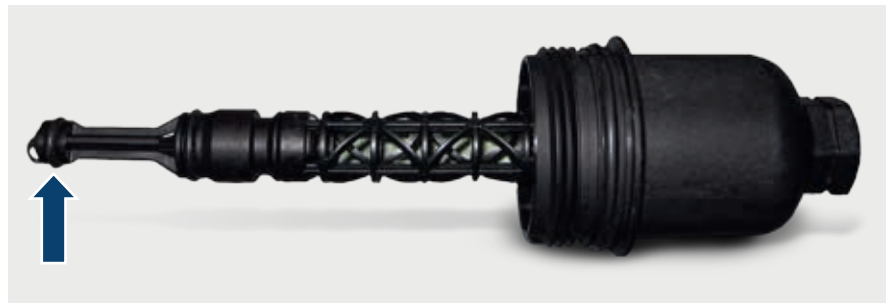
Fig. 1: Plastic tube at the oil filter cap (MB OM611, OM646, M271)
Detail: Drainage valve seal – keeper with sealing ring

The illustrated version (Fig. 1) shows a keeper at the end of the plastic tube. This keeper closes the drainage borehole with the oil filter cap screwed in. The drainage borehole is opened when the oil filter cap is unscrewed. This causes the oil collected in the oil filter housing to drain into the oil pan.

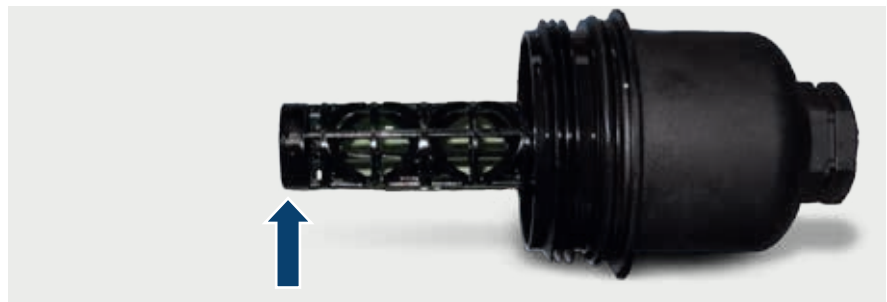
Due to a fracture of the plastic tube at the oil filter cap (Fig. 2), the pressure oil coming from the oil pump drains off into the oil pan unchecked. There is a loss of engine oil pressure resulting in the engine problems and damage described above.

Fig. 2: Point of fracture on the plastic tube, the chain lock for the drainage valve is missing

When changing the engine oil, ensure safe handling of the oil filter unit. The plastic tube on the oil filter cap is sensitive to application of a force and can break. The point of fracture (Fig. 2) can occur in different places. When removing the oil filter cartridge, the broken off plastic tube often gets stuck in the oil filter cartridge and is disposed of as well, without noticing.

Furthermore, the elastomer sealing rings on the oil filter cap must always be replaced as well.
