OBD and secondary air system

Finding and remedying faults

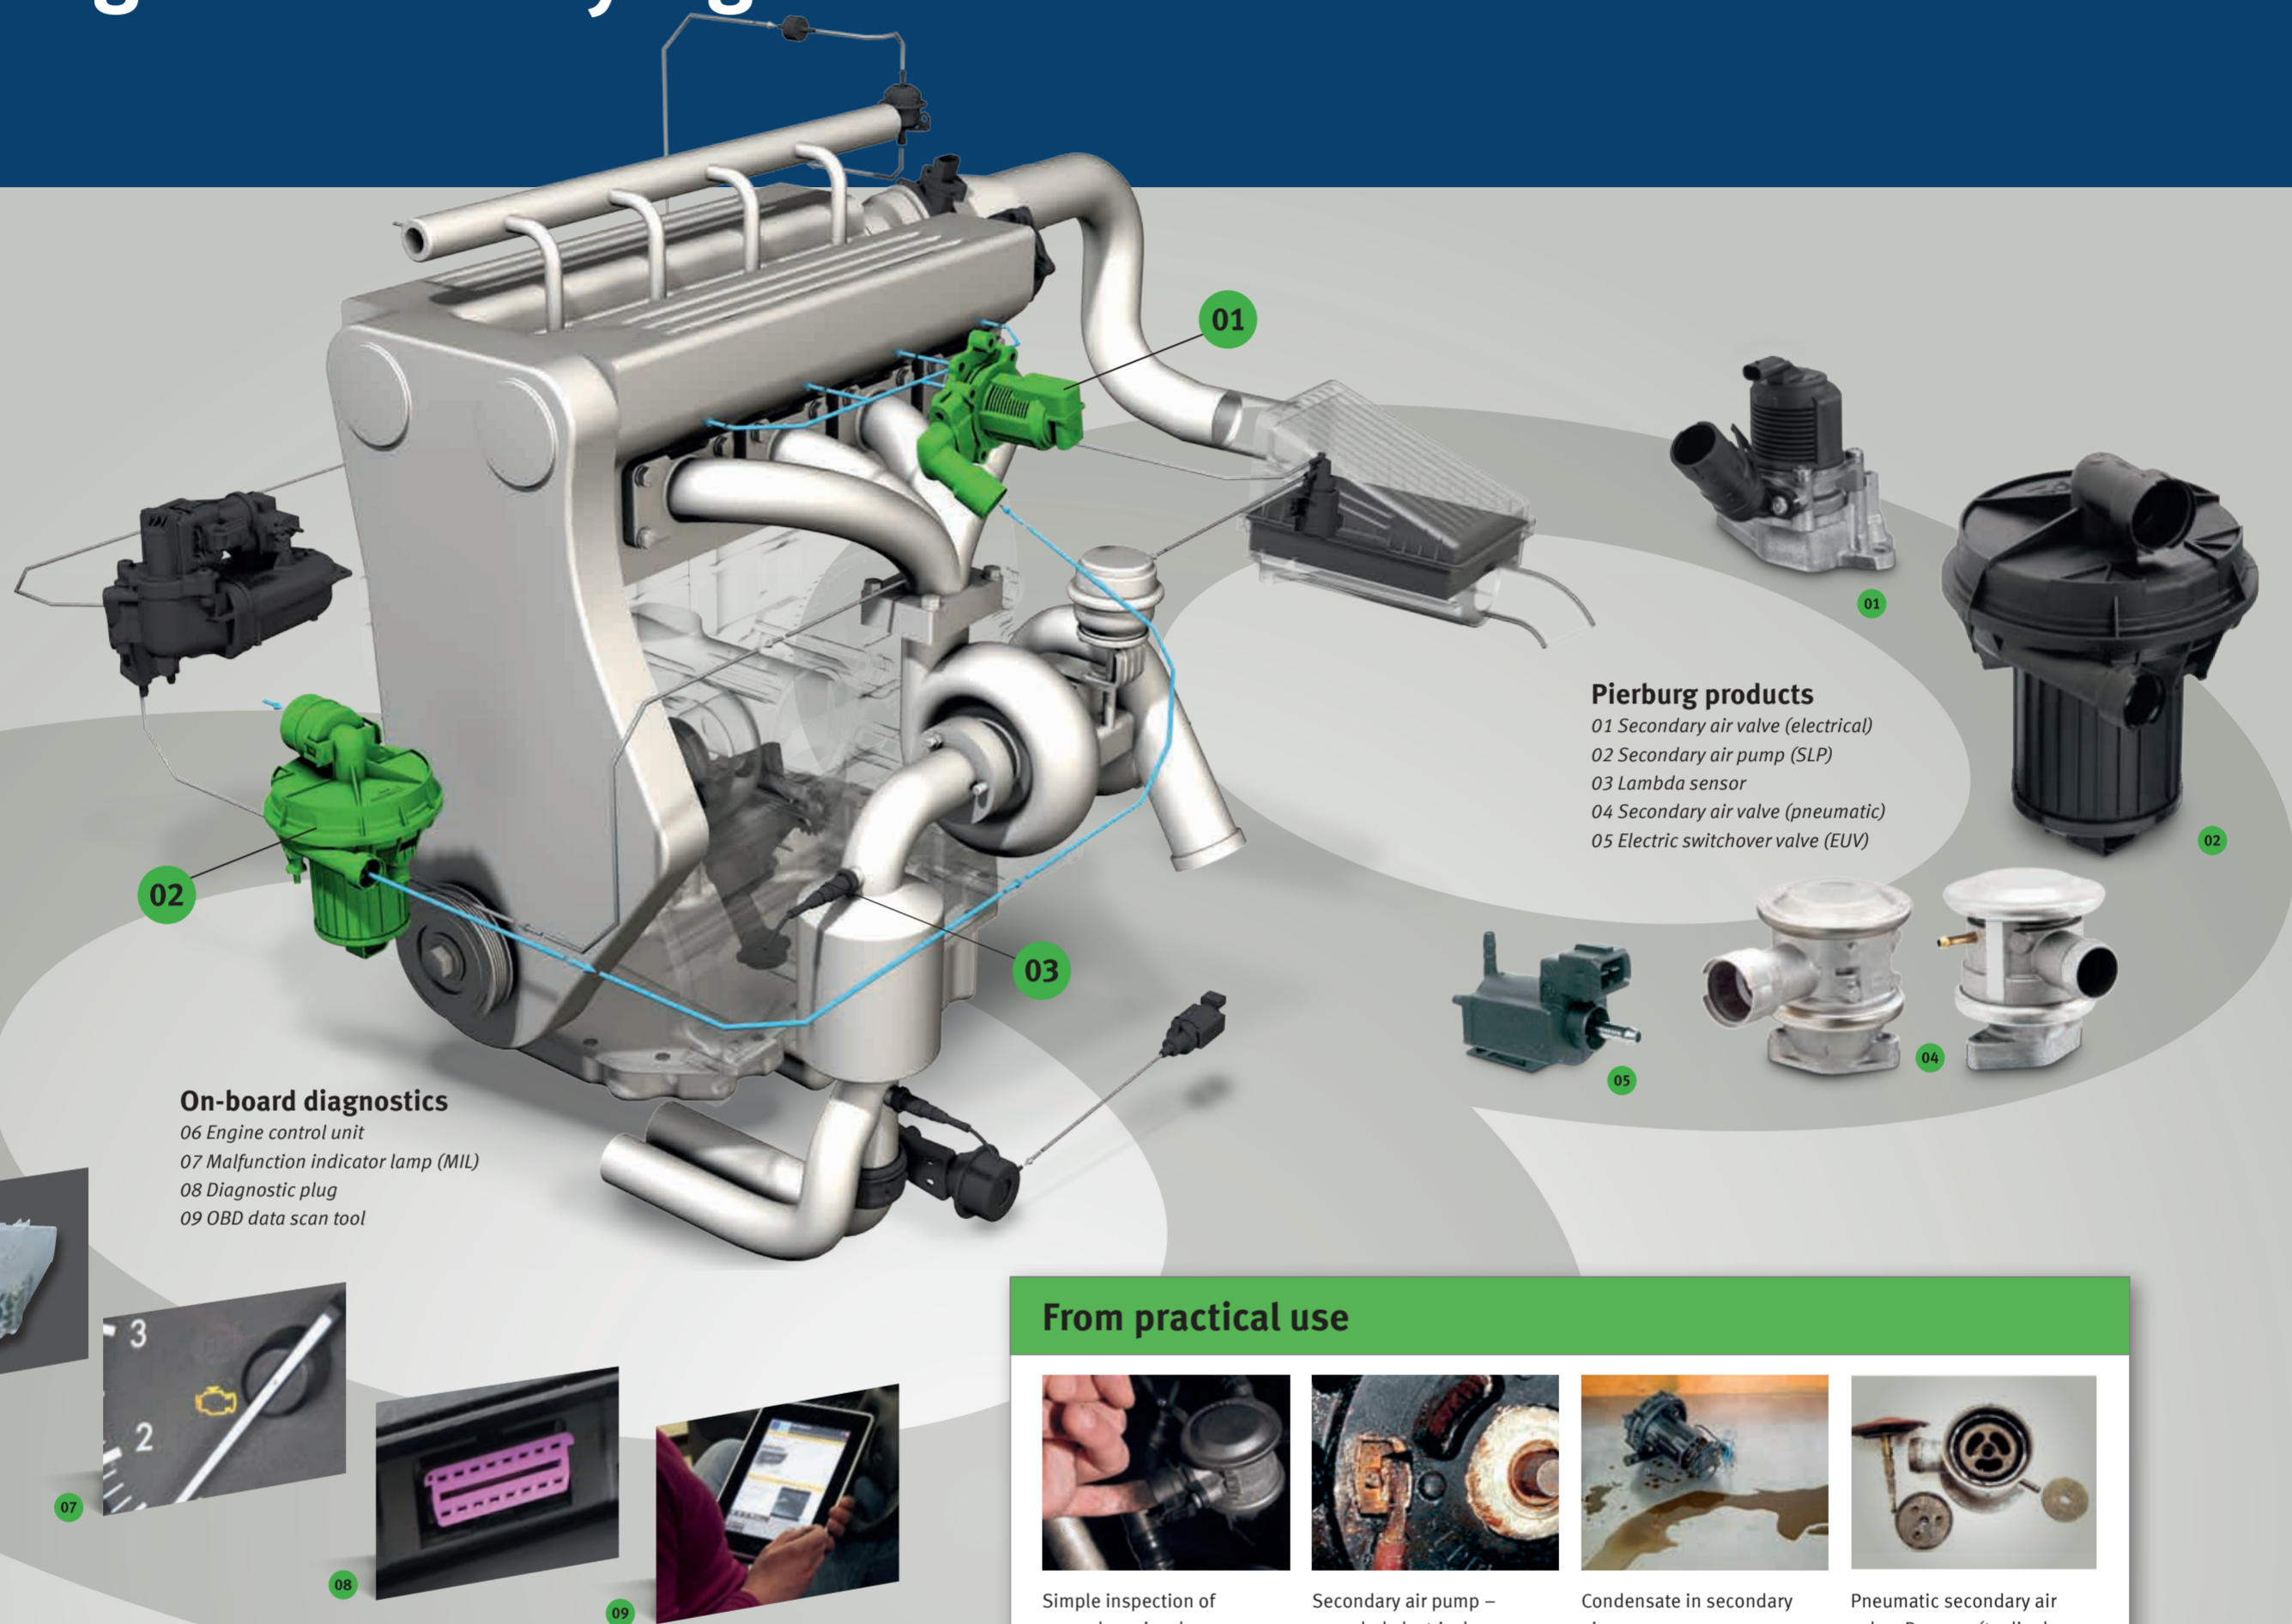
- 01 Secondary air valve (electrical)
- 02 Secondary air pump (SLP)
- 03 Lambda sensor
- 04 Secondary air valve (pneumatic)
- 05 Electric switchover valve (EUV)

- 06 Engine control unit
- 07 Malfunction indicator lamp (MIL)
- 08 Diagnostic plug
- 09 OBD data scan tool
