Valve guides

Practical tips – Replacement and Repair

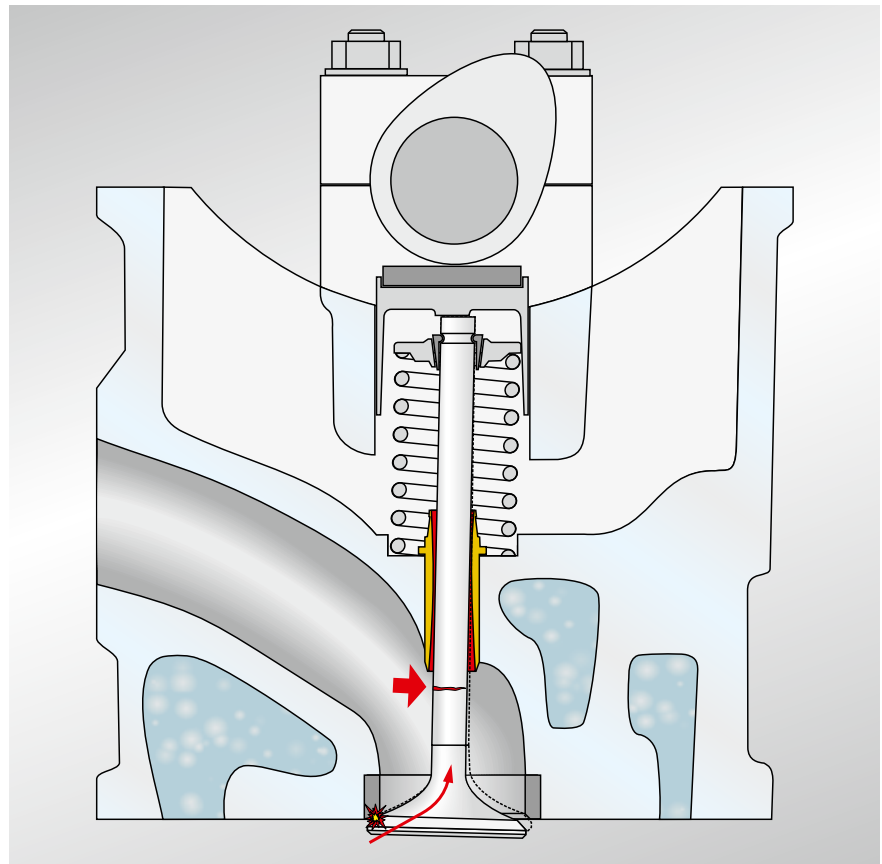
Fig. 2

For valves with a stem diameter of less than 8 mm in particular, knocked out valve guides have a big impact. In case of a knocked out guide, the valve head rests eccentrically on one side of the valve seat and is pulled into the seat with the clamp force of the valve spring(s) (fig. 2). This can cause the valve to break over a longer period of time. Due to the resulting alternating bending stress, the valve breaks at the intersection of stem and valve head. For valves that are operated via rocker arm or finger type rocker, knocked out valve guides result in an increased radial application of force on the valve stem. As a result, the valves break in the groove area for the valve cotter halves.
