Valve guides

Practical tips - replacement and repair

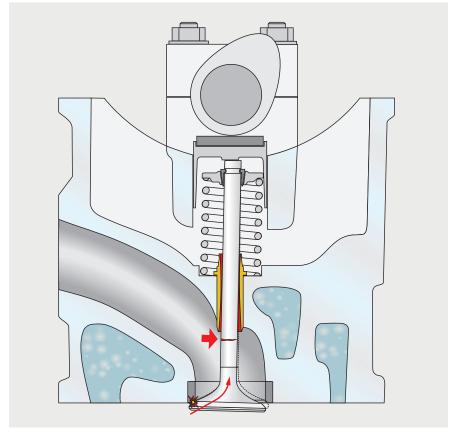
Fig. 2

For valves with a skirt diameter of less than 8 mm in particular, knocked out valve guides have a big impact. In case of a knocked out valve guide, the valve head rests eccentrically on one side of the valve seat and is pulled into the seat with the clamp force of the valve spring(s) (Fig. 2). This can cause the valve to break over a longer period of time. Due to the resulting alternating bending stress, the valve breaks at the intersection of the skirt and valve head.

For valves that are operated via rocker arm or finger type rocker, knocked out valve guides result in an increased radial application of force on the valve stem. As a result, the valves break in the groove area for the valve cotter halves.
