## Diamond-coated crankshaft washer

to fit

Audi A6

Volvo 850, S70, S80, V70 I, V70 II

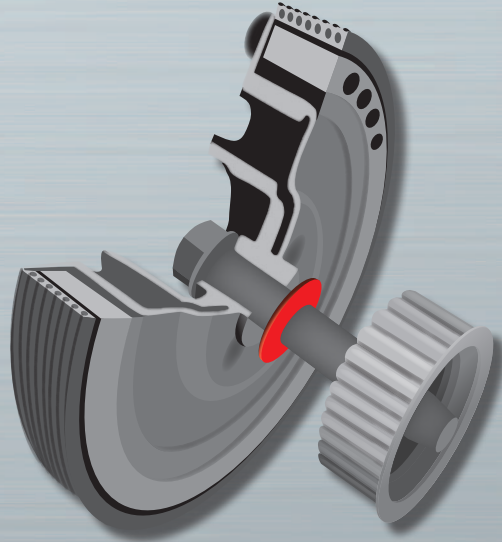
Despite replacing the belt pulley, it still slips.

The diamond-coated crankshaft washer was not replaced when the belt pulley was replaced.

The diamond-coated crankshaft washer sits between the timing-belt pulley and the TVD crankshaft pulley and assists with the smooth transmission of drive. If a diamond-coated crankshaft washer is not used, even if the crankshaft gear bolt is tightened to specification, this cannot prevent the TVD crankshaft pulley from slipping, as it does not provide the same continuous transmission of drive as the (replaced) diamond-coated crankshaft washer does.

**Therefore, it is absolutely essential to use, and, if necessary, replace a diamond-coated crankshaft washer.**

SWAG's crankshaft washer has a high-quality nickel-diamond coating which prevents the belt pulley from spinning. In addition, optimum power transmission is guaranteed.

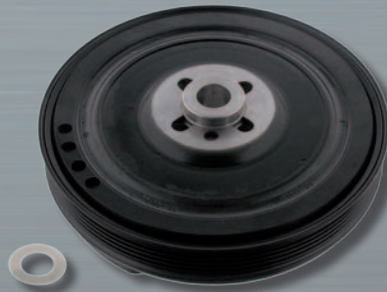
TVD crankshaft  
pulley rep. kit

In order to avoid costly consequential damage, the SWAG vibration damper repair kits for Volvo 850, S70, S80, V70 I, V70 II, VW Crafter/T4 and Audi A6 include the diamond-coated crankshaft washer.
