## Alfa GT, 147 and 156 Stiff Clutch Symptoms on JTD Models

The Valeo Service Technical department have received numerous calls concerning certain Alfa Romeo models experiencing the symptom of a “stiff” or “creaking” clutch both before and after a clutch change. This Technical bulletin has been produced to identify potential issues, external to the clutch, that will cause the above symptom.

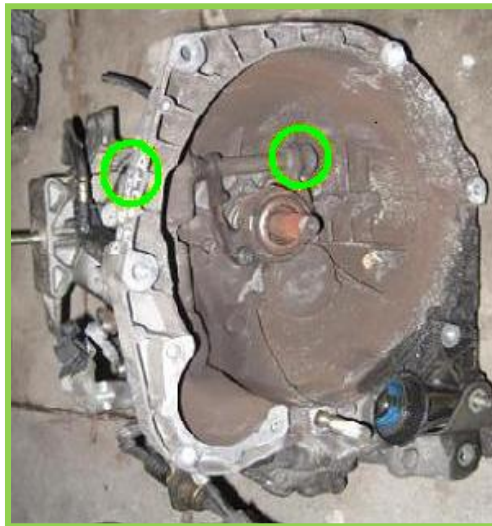
In order for the release arm to pivot correctly it is important that special attention is given to the bushes that the release arm is situated in on the bell housing. A common issue on the Alfa Romeo models is that the bushes tend to corrode/clog and partially seize up causing difficulty when trying to select gears. The bushes should be checked and cleared of any dirt or debris, or if worn, replaced with new bushes. Valeo are also aware that in some Alfa models the bushes have been modified from their original design. The reason for the modification is to allow moisture to drain from them more efficiently. To confirm that the bushes have been modified in your vehicle please contact an Alfa Romeo dealer.

*Check the release arm bushes for wear and replace them if necessary to ensure the release arm does not seize. Also the release bearing should be checked for dirt as this may cause it to bind on the shaft.*

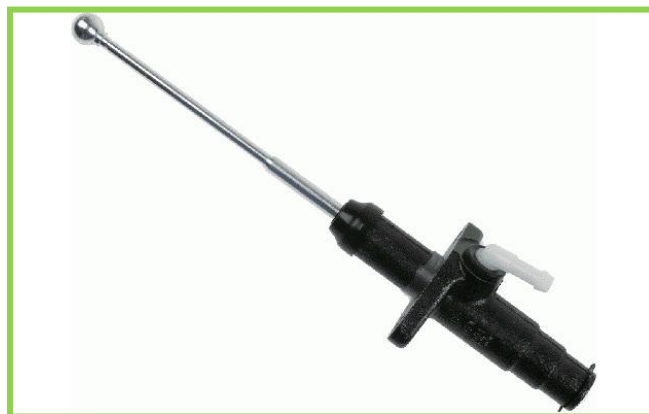
If the vehicle is being repaired due to a heavy or creaking clutch the master cylinder should always be checked to ensure it is working to its full capacity. If the release arm has seized or the release arm bushings need replacing it causes an increase in pressure required to operate the clutch. This causes unnecessary stress on the master cylinder thus potentially damaging the seals / rubbers. Similar checks should also be made to the clutch release cylinder.

Also a visual check should be made to the clip securing the master cylinder pushrod to the pedal has not snapped or worked itself loose.
