826033 / 826565 engine vibration

Part Number: 826033 / 826565

For Vehicle: Citroen Berlingo

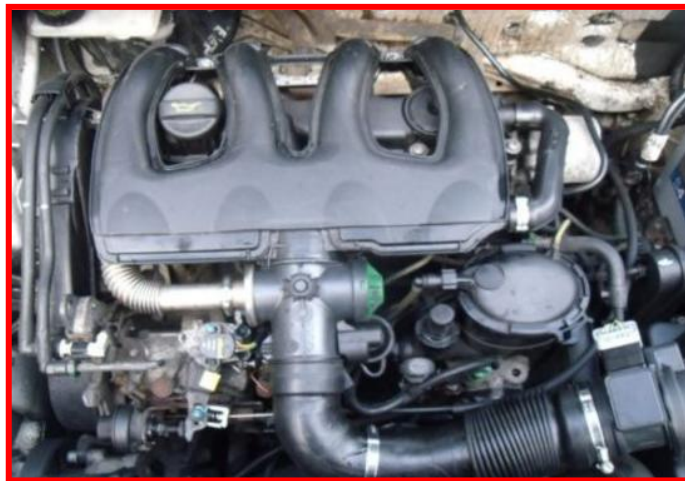
On this vehicle the engine cover mounts are prone to damage. If these mounts are damaged or worn vibration can be felt through the transmission during start up, moreover this causes the oil filler cap to loosen which produces an oil leak from the engine.

There are multiple engine mounts on the vehicle but in particular one at the back of the engine near the bottom bracket which attaches the engine to the body is particularly prone to wear. Over time, and if not attended to, it will cause the engine to rock back and forth.

Check the oil filler cap is not loose and pay special attention the engine mounts
