## 251496 horn function failures

Part Number: 251496

For Vehicle: Citroen Berlingo, Peugeot Partner

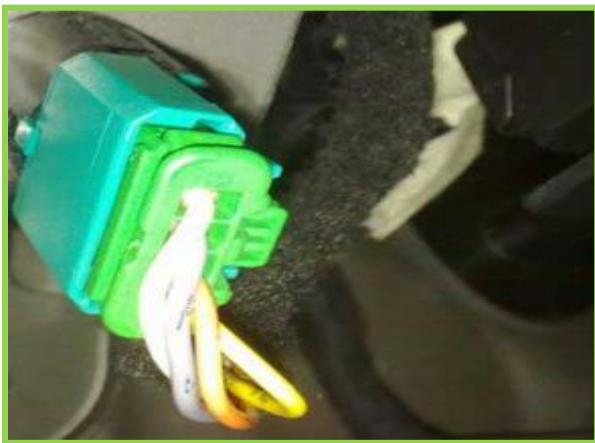
Please note there is a recognised fault on Citroen Berlingo and Peugeot Partner models where the wiring loom leading to the brake light switch is damaged. This damage leads to premature failure of the horn.

Example of brake light switch and wiring

Before replacing Valeo column switch 251496 it is good practice to check the brake light switch is in good working order. Visible signs of damage to the vehicle wiring loom leading to the brake light switch, the engine compartment fuse box and the body control unit can lead to failure of the horn function and/or the low beam light function.
