## Take care when re-gassing Fiat and Ford air - conditioning loops

Part Number: 625201, 710297, 625202, 625295

For Vehicle: Fiat, Ford

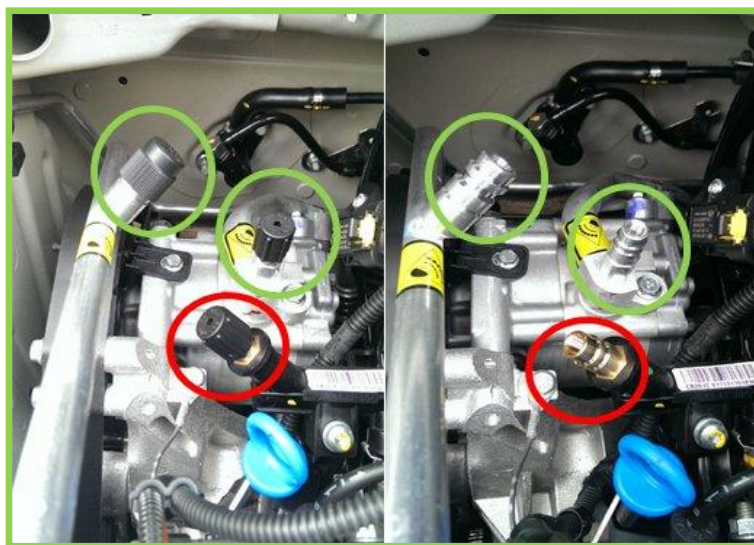
For certain vehicle manufacturers such as Fiat and Ford, the Fiat 500 and Ford KA models in particular, there can be up to three valves within close proximity. These valves include the high pressure R134a Schrader valve (pictured below on the left highlighted in green), the low pressure R134a Schrader valve (pictured below on the right highlighted in green) and the connection to the fuel rail (pictured below highlighted in red) which is the same size as the low pressure R134a Schrader valve.

The Valeo Service tech care team have recently seen a number of issues where the air conditioning service machine has been attached to the fuel rail instead of the low pressure port. Petrol has then been extracted into the refrigerant tank. The cost to repair this is very high due to the necessity to have the machine cleaned out and all the internal filters and associated parts replaced.
