## Applying sealant on CSC's 804571, 810027 and 804506

Part Number: 804571 - 810027 - 804506

For Vehicle: Ford applications

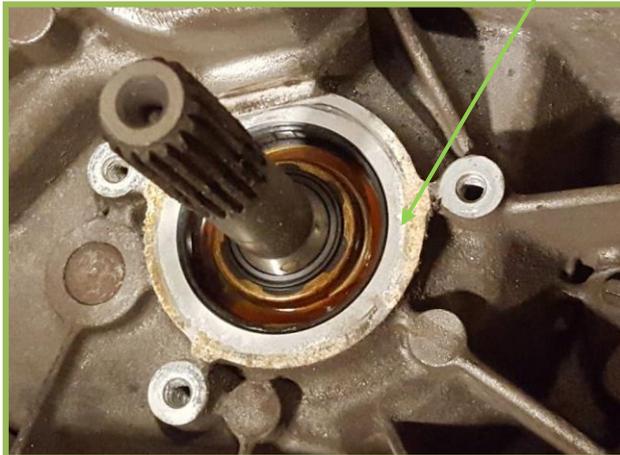
*Ensure gearbox mating face is clean and clear of debris*

It is required that sealant WSK-M2G348-A5 be used on the back plate of the CSC to create a gasket between the back plate and gearbox mating face.

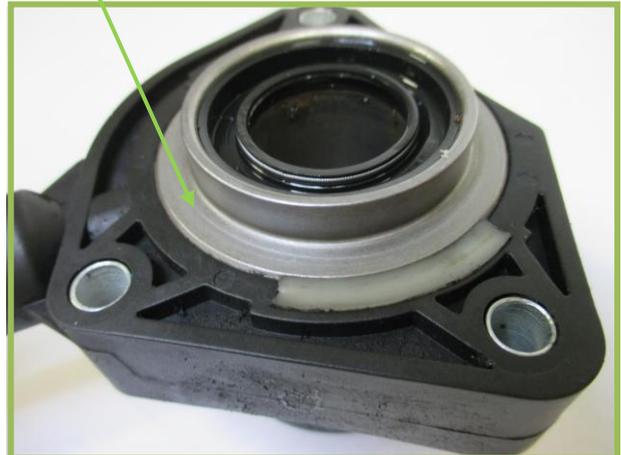
*Apply the gasket compound to the CSC back plate*
