515075 failure due to a faulty wiring loom

Part Number: 515075

For vehicle: Mercedes Benz A-Class

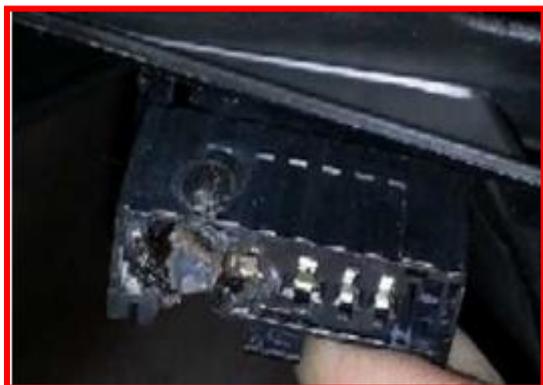
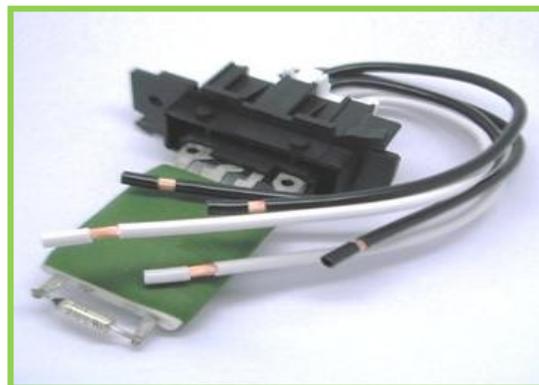
Valeo Service is also aware of an aftermarket wiring loom upgrade/repair kit that has extra cables (as seen above). This isn't a mistake; these extra cables share the current between adjacent terminals, to assist with the overheating issue in the original.

If this occurs the heater resistor or blower motor will not need replacing, only the wiring loom itself.

Please note: to eliminate the possibility of making a wiring mistake Valeo Service recommend cutting and crimping only one cable at a time. The loom comes with ready-terminals and crimp connectors, so only one process of crimping and stripping is required.
