801502 - Fitting Instruction

Part Number: 801502

For Vehicle: Avensis, Carina, Celica, Corolla, MR2 Mk3, Rav 4, Yaris.

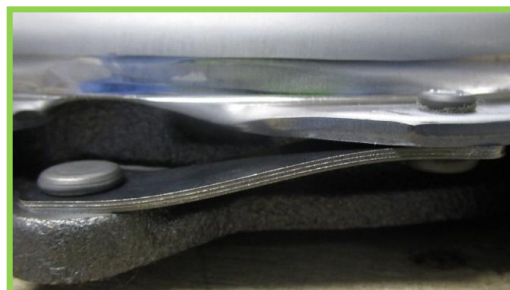
New part taken from Valeo stock; shows no deformation/damage to the straps

Please check each of the drive straps prior to fitment to ensure the cover plate has not suffered any trauma. There should be no air gaps or space between the metallic strips that make up each strap and each strap should have the same profile (shape).

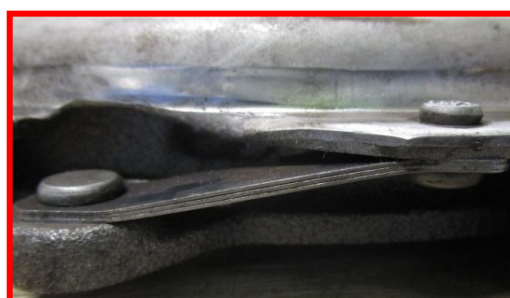
The Valeo Service UK warranty department have received returns of 801502 clutch kits with a fault description of "light pedal, difficulty in changing gears and not clearing gears". After analysis of the returned parts, it was discovered that the cover plates had deformed drive straps. The effect of a deformed strap means the pressure plate will not lift correctly when the diaphragm spring (fingers) is actuated therefore reducing the drive plate clearance and making it difficult to select gear. Due to the reduced load on the diaphragm spring, the clutch pedal can feel lighter than normal.

The cause of a deformed drive strap is often one of the following: dropping the cover plate, excessive trauma during transport or an incorrect tightening sequence used when fixing the cover plate to the flywheel.

Fitted part returned as warranty; shows deformation/damage to the drive strap

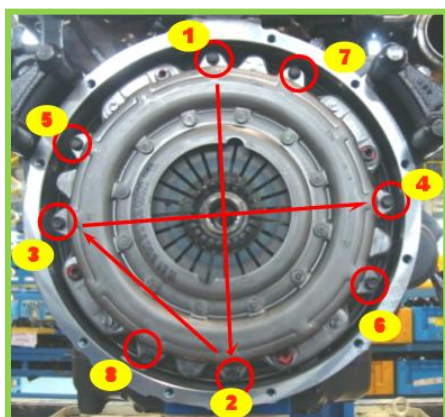
Please see below for the correct tightening sequence provided by our factory of manufacturing. For the specific torque please refer to manufacturing specification.
