Top 3 installation errors to avoid on kits 835035 and 828002

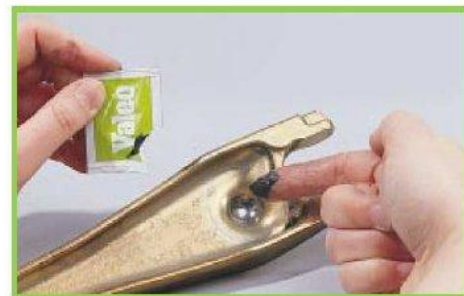
Grease contamination

The Valeo Service warranty department receive a number of returned clutches with issues of juddering or slipping of the clutch. After inspecting the returned parts, there is clear evidence of incorrect, too much or incorrectly applied grease which has radiated from the drive plate hub from centrifugal force and coated the friction surface. Once the grease has come into contact with the friction surface, the coefficient of friction of the drive plate is reduced so it can no longer transmit all of the engine torque resulting in the effect of juddering or slipping. Always check the condition of the gearbox and the engine to prevent oil and other contaminants leaking into the gearbox.

Use the grease applied in the kit sparingly

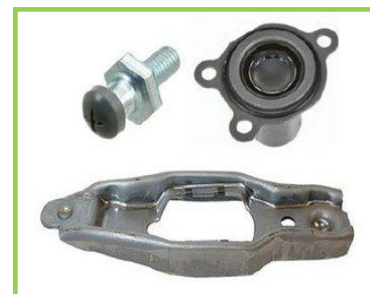
**Figure 3, clutch ball pin, guide tube and release arm*

The Valeo Service warranty department receive a number of returned clutches with issues of juddering or slipping of the clutch. After inspecting the returned parts, there is clear evidence of premature wear to the diaphragm fingers. This is a result of incorrect preload (the release mechanism being incorrectly set) to the release mechanism of the vehicle. This can be attributed to a number of commonly worn parts fitted to the vehicle including the clutch ball pin and clutch release lever (figure 3), the gear synchro hubs (in particular the third and fourth) and both gear wheels.

**Failure to check and replace where necessary will result in difficult gear change or vehicle judder and/or vibration.*
