515074 - Heater Resistor For: VAG Range

Please be aware if failure of the heater resistor occurs, the replacement of the resistor may not solve the problem. Please check the following:

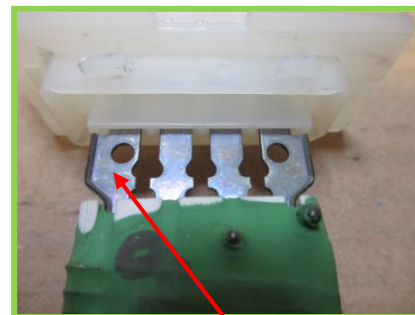
Thermal damage on the pins of the electrical connector due to an overload.

Blueing on the resistors pins

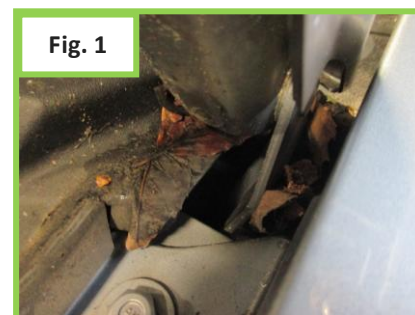
1. Ensure that the windscreen drains are clear of debris (Fig. 1).
2. Ensure that the plastics are covered, correctly fitted and the rubber weather seal is fitted correctly.
3. Ensure no water is leaking on the blower motor.
4. Check that the scuttle panel, specifically the drains around the cabin air filter are not clogged (Fig. 2).

When water leaks onto the blower motor it may generate high current and overload the heater resistor, causing thermal damage.

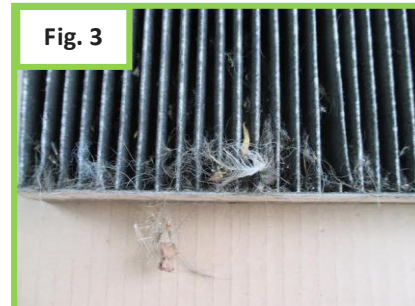
Fig. 3

1. Switch off the engine and all electrics.
2. Rotate the blower motor fan to check for free movement. If there is resistance then the bearing could be rusted internally. This can cause the blower motor to overload .
3. Ensure that the pollen filter is not clogged (Fig. 3). This can cause the blower motor to overload.
4. Ensure the blower motor has no visible rust (Fig. 4).

If any of the above has occurred, it is advised to replace both blower motor and pollen filter. If a new heater resistor is fitted to a vehicle displaying the above symptoms then it will be very likely that the thermal fuse on the resistor will blow due to the additional strain.
